# IDAHO STATE CAPITOL MASTER PLAN

For the Preservation, Restoration and Rehabilitation  
of Idaho's Statehouse

July 19, 2000

DPW Project #99.014

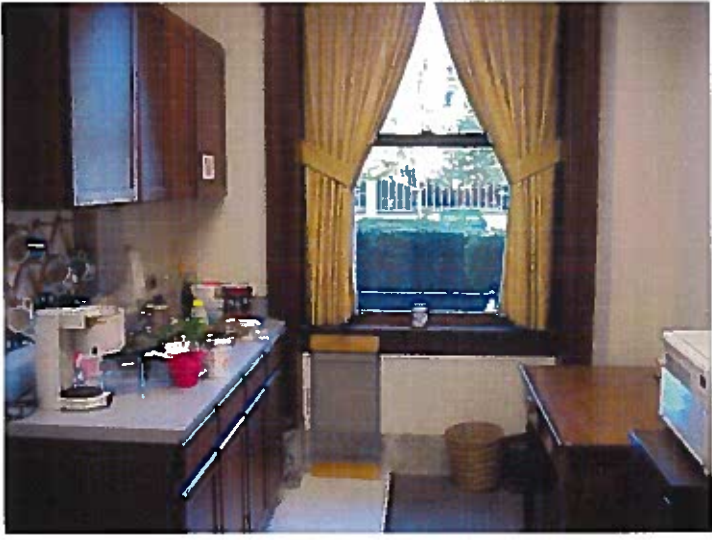
*The introduction of cabinets and modern kitchen appliances has seriously altered the appearance of the room currently used as a staff kitchen (above right). Located on the first floor of the west wing, the former office would likely not be recognizable to one of the original building inhabitants. This situation is unlike that found in the rotunda and its surrounding corridors, which have been well maintained and retain those features that define its unique architectural character (right). The reception area for the Governor's office (above left), located in the west wing, historically functioned as a vault serving the Bookkeeper's and Stenographer's Office. Comparison of the historic and existing floor plans reveal this change necessitated the removal of historic walls.*

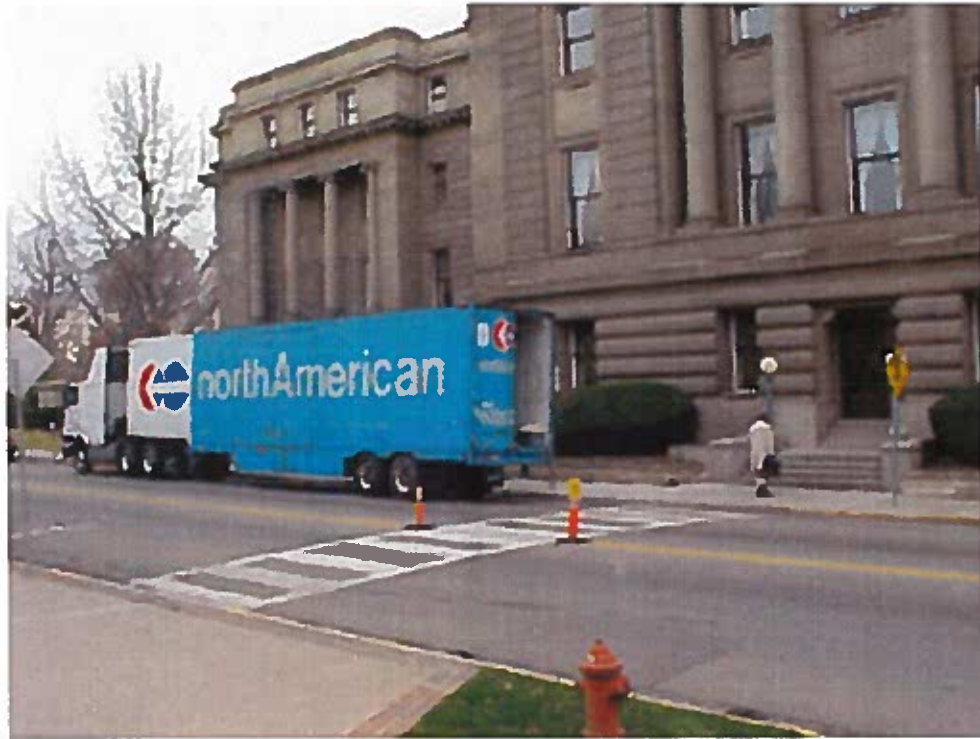
*Vehicles are currently parking along State Street within feet of the Capitol building. Consideration should be given to limiting traffic or converting State Street, between Sixth and Eighth Streets, to a pedestrian mall.*

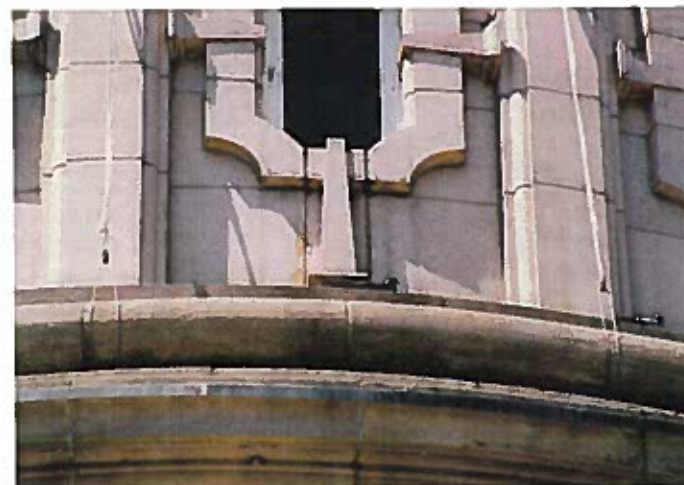
*A continuous flashing strip is located in the upper lip of the cornice stone. Although darkly stained, the flashing appears to be in fair functional condition, except for two locations where approximately 4 feet of flashing is missing. The stone at these locations exhibit surface erosion from weathering. Consideration should be given to replacing all flashing to improve long-term maintenance and reduce further stone deterioration.*

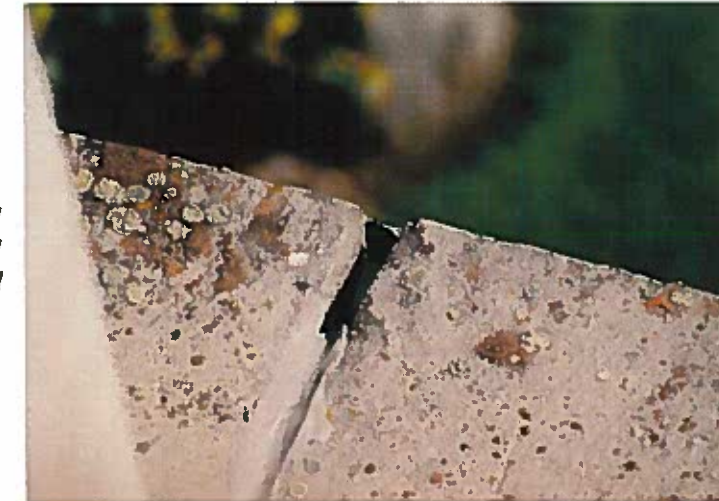
*Medium to dark brown ferrous stains were evident on the surface of the south granite entry stairs; along the base of the building; and under the cornice on the southwest elevation.*

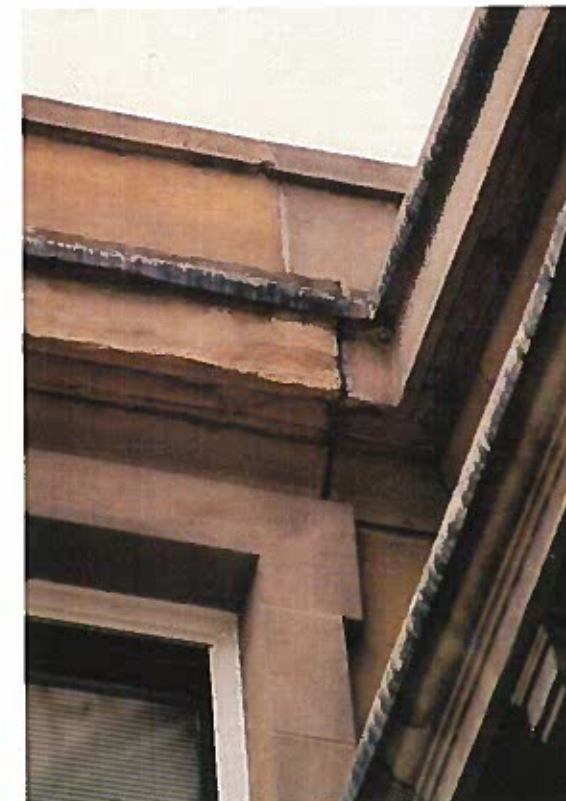
*Isolated sandstone panels located below the granite base course, at the cornice and at the parapet exhibit moderate surface loss from weathering. Weathered stone exhibits a change in surface texture. Rounded corners and deeply grooved surfaces are typical of heavily weathered panels.*

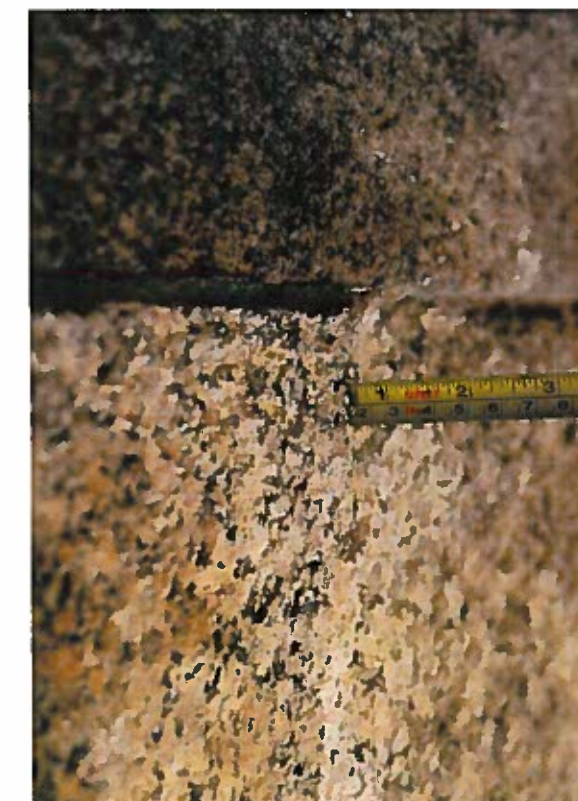
*Exfoliated granite was observed under the entry stair pavilions. In the most extreme case, approximately 1/2 inch of stone has exfoliated.*

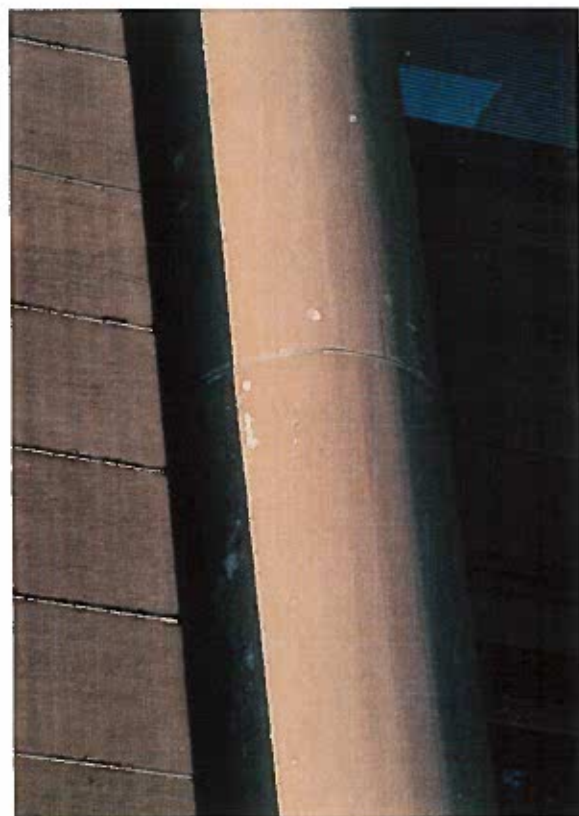
*Several discolored mortar patches were observed at many of the columns. These patches typically range in size from 1 to 4 square inches in area. The lighter color may be due to a difference in dirt accumulation between the patch and the adjacent stone.*

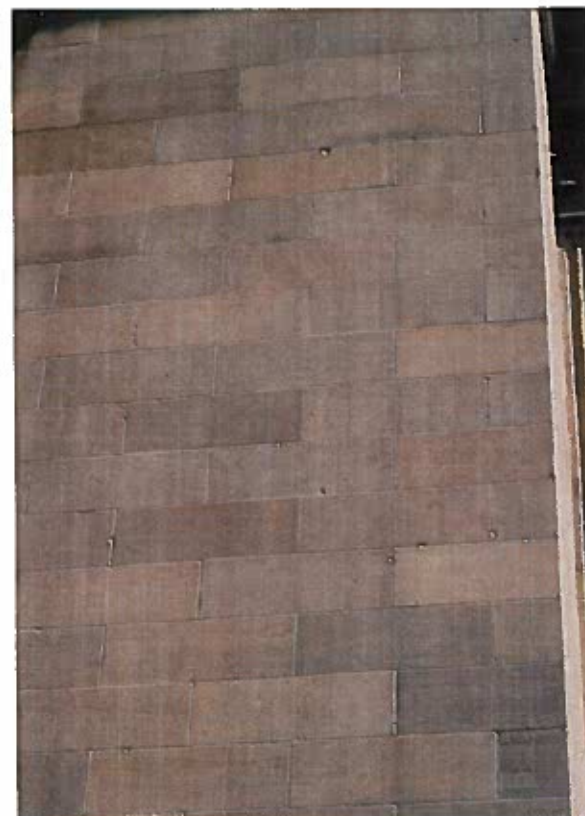
*Several regions of shallow spalls were identified on sandstone units. The spalls are typically less than 1 inch deep and are only visible when shadows are cast in the spalls.*

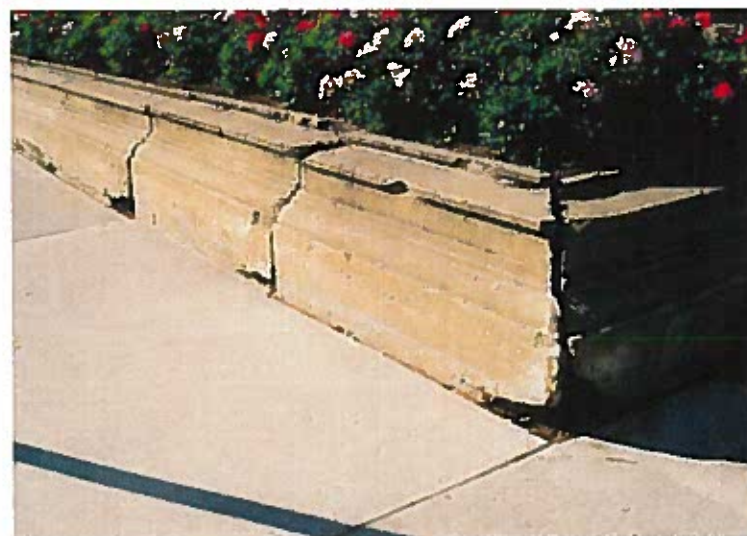
*Most of the sandstone planter walls around the perimeter of the building are weathered and spalled. Joints are deteriorated and open. Several units are displaced. These elements may have been subsequently added and may not be original to the 1920 Capitol building completion.*

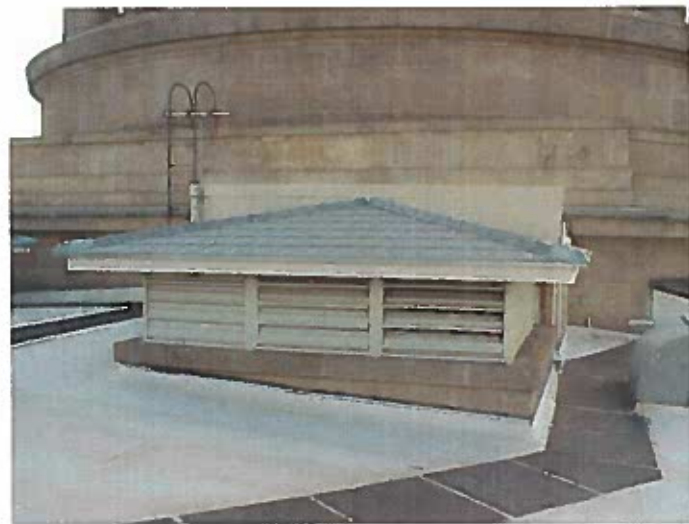
*The four central light wells are retrofit with hip roofs clad with galvanized sheet metal shingles. The sides of the closure are clad with white raised-rib metal siding. This construction is not consistent with the original palette of materials. These roof enclosures are recommended to be replaced with translucent systems to re-introduce light into light wells.*

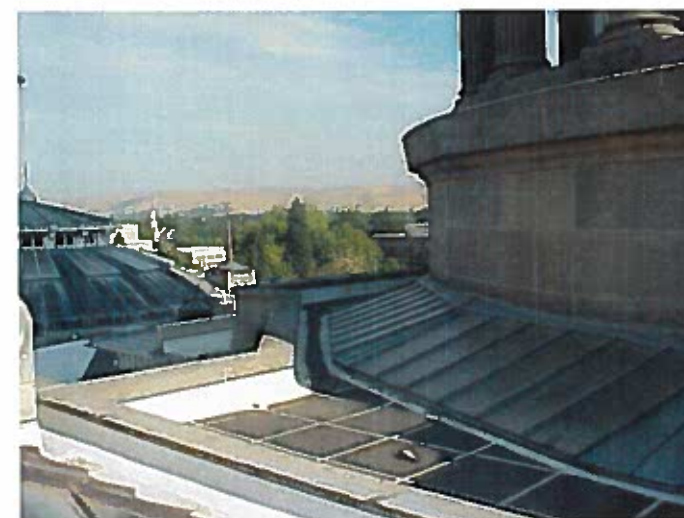
*Some wire-glass units remain near the drum, which have been damaged by ice sliding from the dome.*

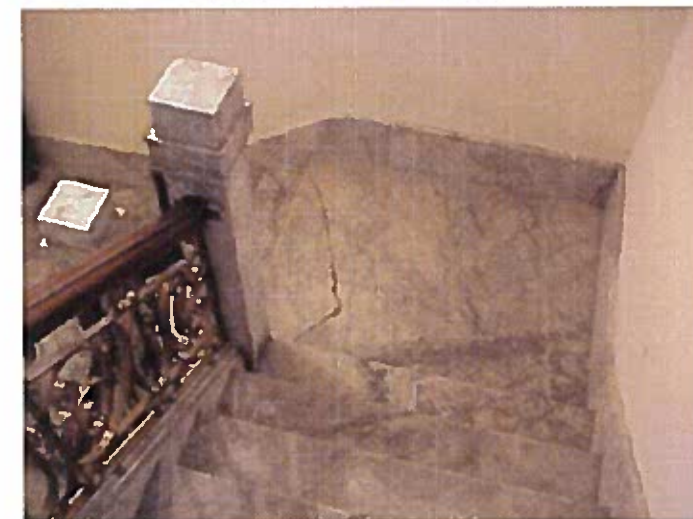
Some marble surfaces are in need of repair. The floor along the east and west additions show signs of settlement cracking that may be credited to the 1959 Yellowstone earthquake. One of the marble landings at the fourth floor attic stair is also badly cracked. The marble railing on the fourth floor has been etched with visitor names in several locations.

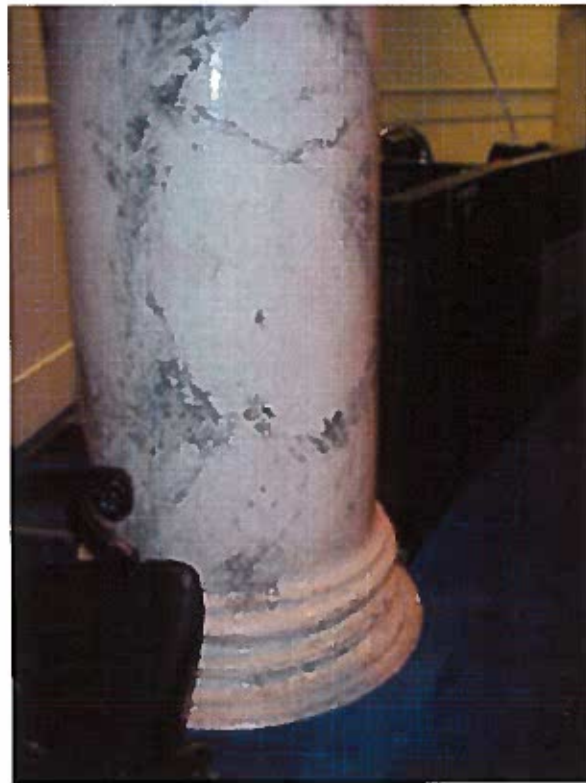
*Columns currently show signs of aging, displaying hairline cracks in various degrees of severity. The columns in the House (above) and Senate chambers appear to have more cracks than the columns in the rotunda due to higher use and abuse with furnishings.*

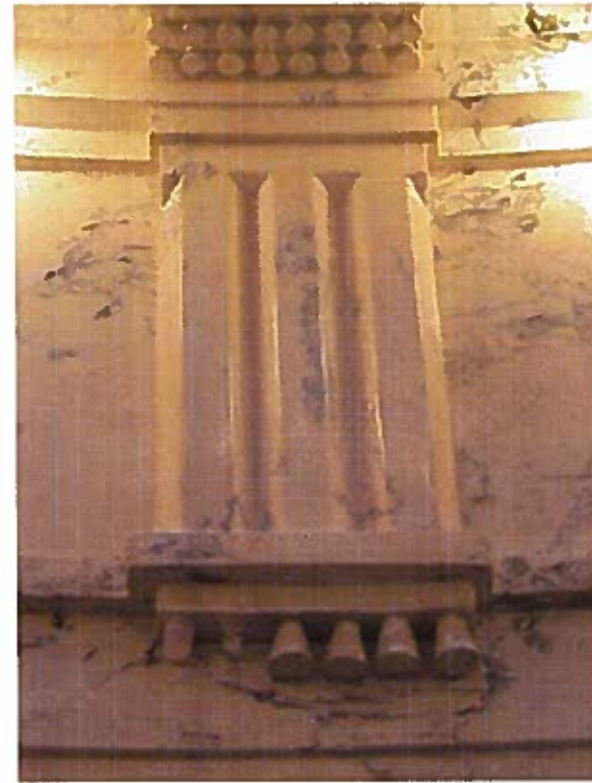
*Decorative wall and ceiling triglyphs throughout the building are formed of plaster, wood and marble. Most of the exposed plaster is in good condition; however, numerous pieces and elements are missing or damaged.*

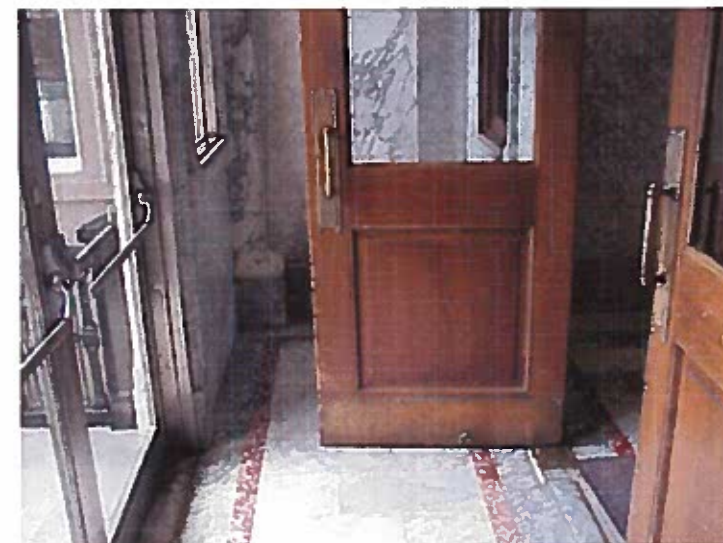
*Much of the wood doors and hardware throughout the building are in good condition; however, many of the main entry doors are scratched and worn (left, second floor east entry).*

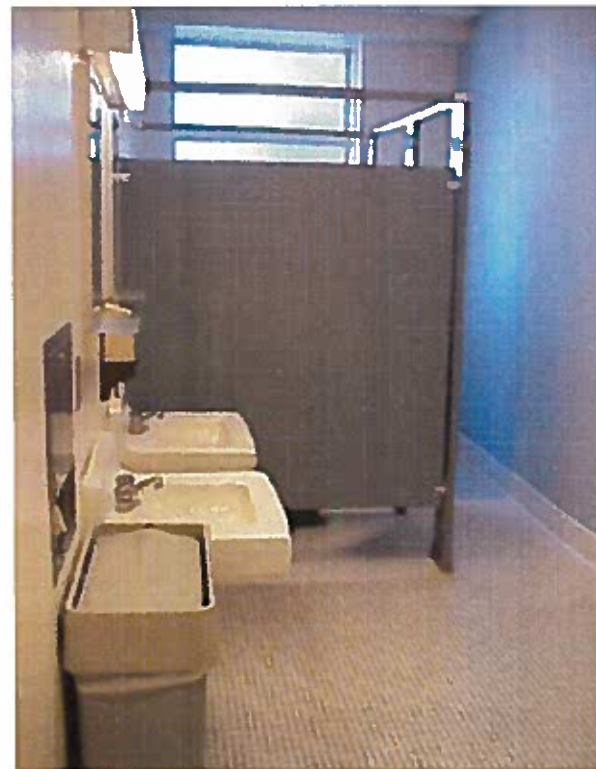
*The remainder of the toilet rooms have been remodeled using modern finish materials (above, women's room). Toilet rooms appear to be in fair condition.*

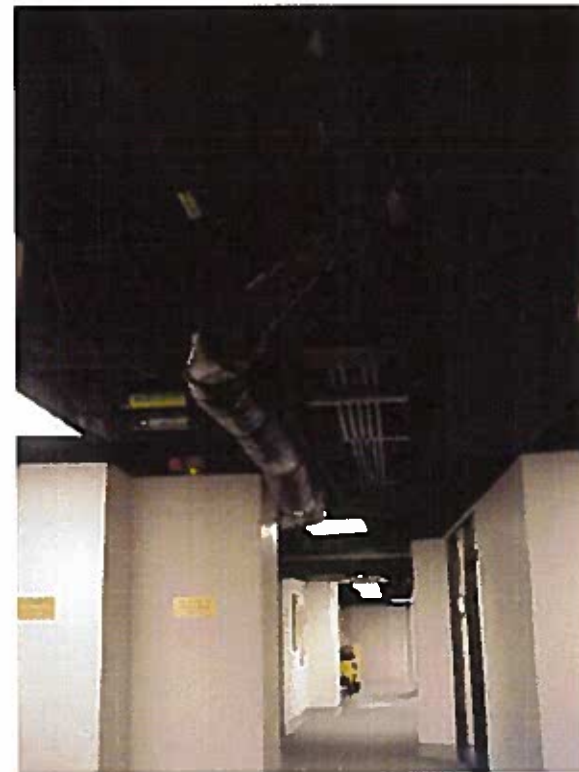
*The ceilings in the basement near the rotunda have excessive amounts of conduit, piping and ductwork exposed to the area. Consideration should be given to removing or relocating these elements.*

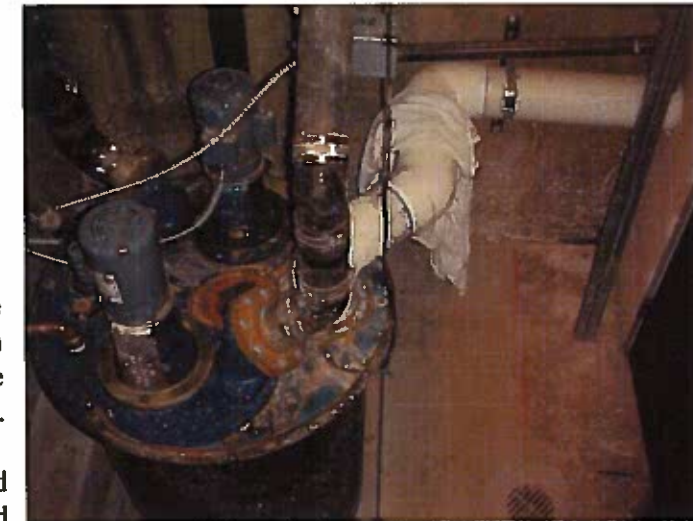
*Storm drainage discharge into sewage ejector*
