# IDAHO STATE CAPITOL MASTER PLAN

For the Preservation, Restoration and Rehabilitation  
of Idaho's Statehouse

July 19, 2000

DPW Project #99.014

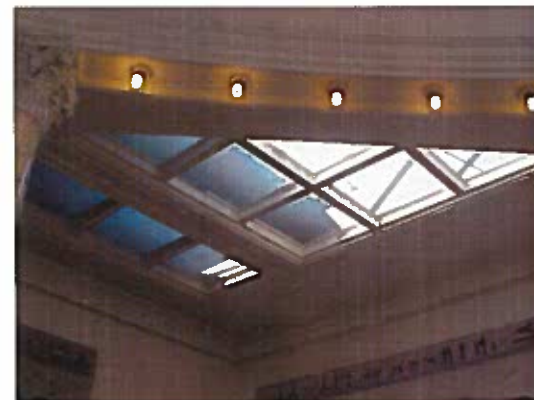
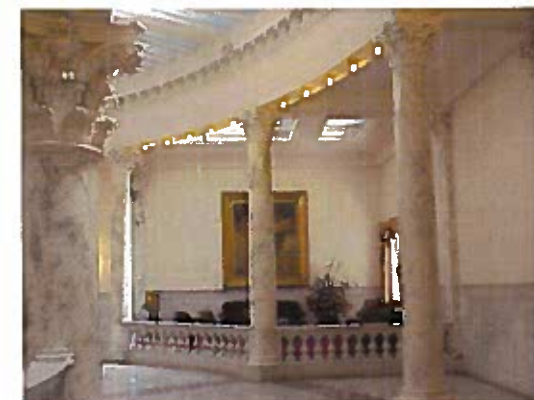
The historic photograph above shows the stairwells of the rotunda illuminated, illustrating the effect of the skylights that open above the fourth floor. Flooring was placed directly beneath to create exhibit spaces at that level. This situation has resulted in light not penetrating to the lower levels of the building in the central portion spaces.

- **Remove the floor structure over stairwells at the fourth floor.** For the purpose of displaying historic furniture, floor structures have been added at the fourth floor level over the south set of stairs. It is recommended the floor be removed and the glazed area be restored.

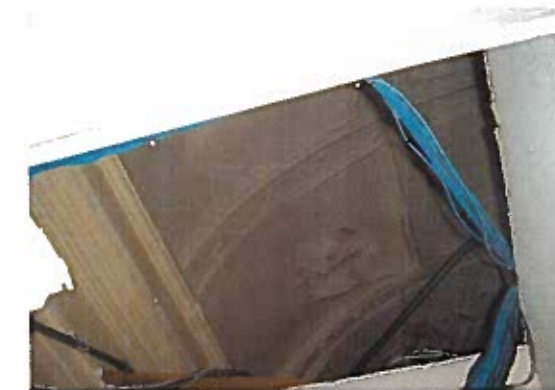
Currently, the area originally designed as Statuary Hall on the fourth floor has been remodeled to house offices. For years the vaulted ceiling, which was constructed as part of the original design, has been concealed by a suspended ceiling. The original ceiling is intact, but will require repair if it is to be exposed again, as recommended.

- **Restore the original reception lobby and Statuary Hall on the third and fourth floors.** These spaces have been converted to office space. It is recommended that their architectural significance be restored.

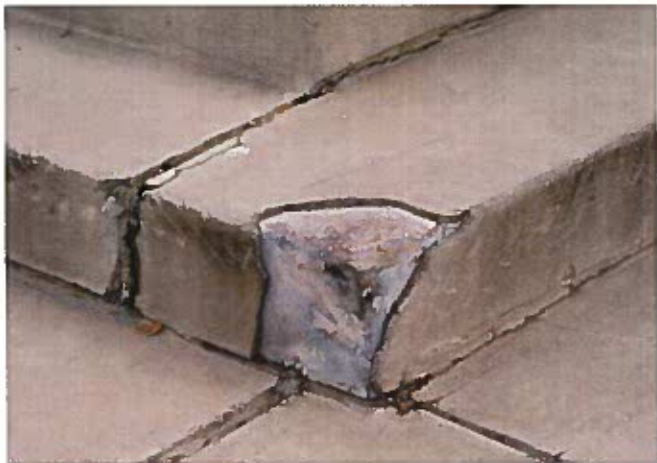
*The concrete topping slab on the east and west stairs is deteriorated in several locations, presenting a tripping hazard as well as allowing the penetration of moisture into the structure below.*

- Remove east and west entry stairs and replace with new concrete stairs.
- At various locations where present, remove deteriorated mortar joints and point with new mortar. Test existing mortar to determine type needed.

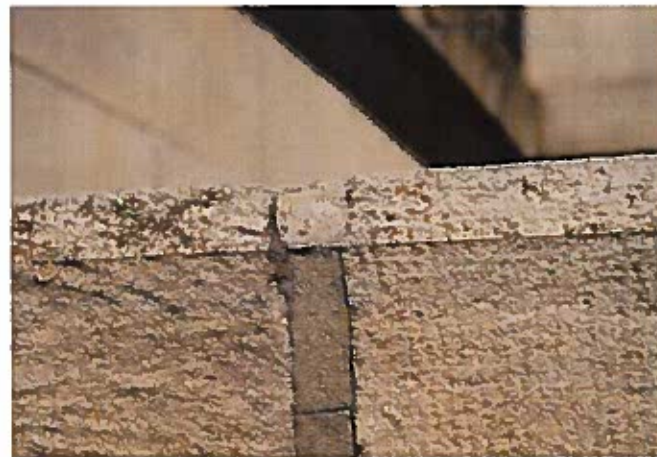
*Most of the mortar joints at the walls and drum were observed to be in good condition. Joints at the cornice and parapet level of the walls and the entry pavilions are most deteriorated. Some mortar joints show evidence of re-pointing.*

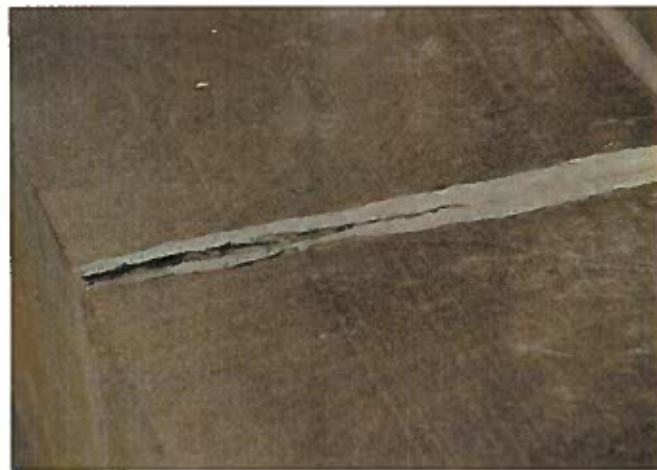
*Sealant joints at the water table are typically deteriorated and have exhibited cohesive failure. Sealant joints at the parapet and terra cotta dome were observed to be in good condition.*

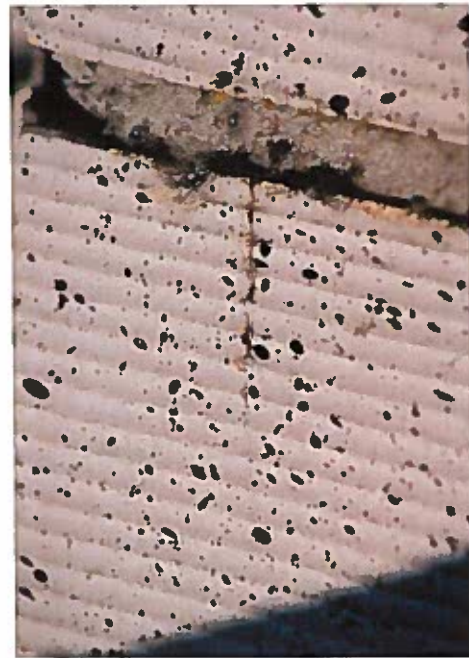
*Minor cracks were observed throughout the exterior walls, drum and dome, mainly at the cornice and at corners of window openings. Some cracks have been filled with sealant or mortar. Approximately 10 minor cracks were observed in the terra cotta dome.*

*Only a few deep spalls (greater than 1 inch deep) were observed in sandstone units. Locations of deep spalls correspond to areas of maximum weather exposure such as the parapet and cornice and areas with missing flashing.*

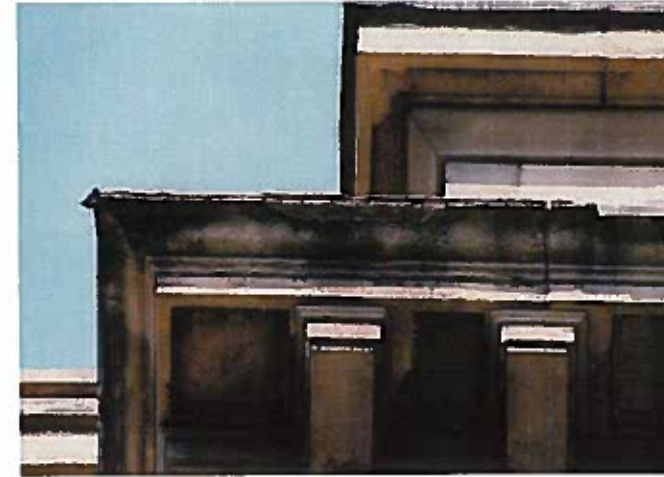
*A continuous flashing strip is located in the upper lip of the cornice stone. Although darkly stained, the flashing appears to be in fair functional condition, except for two locations where approximately 4 feet of flashing is missing. The stone at these locations exhibit surface erosion from weathering. Consideration should be given to replacing all flashing to improve long-term maintenance and reduce further stone deterioration.*

*Several of the lantern balusters exhibit characteristics of cast stone, not typical sandstone. Several are eroded and cracked. The casting joint in several is cracked.*

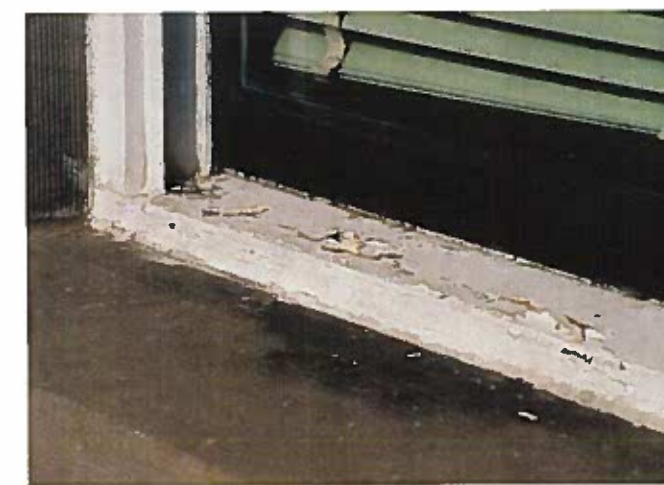
*The paint on most windows is peeling. The extent of deterioration varies with exposure and location. Evidence of wood deterioration was not observed.*

*Dirt accumulation was observed throughout the exterior walls and drum of the building. Contrast between new and old sandstone can be seen at the units replaced on the northeast side of the north wing following the 1991 fire.*

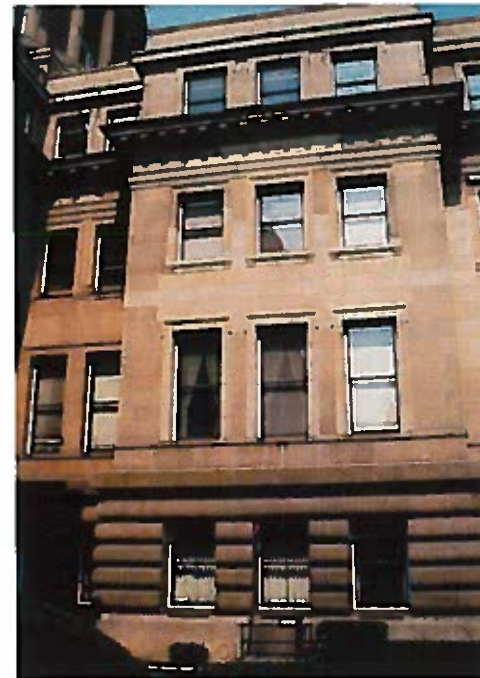
*Brown, black, green and orange biological growth were observed at most horizontal wall surfaces, and portions of the cornice and parapet.*

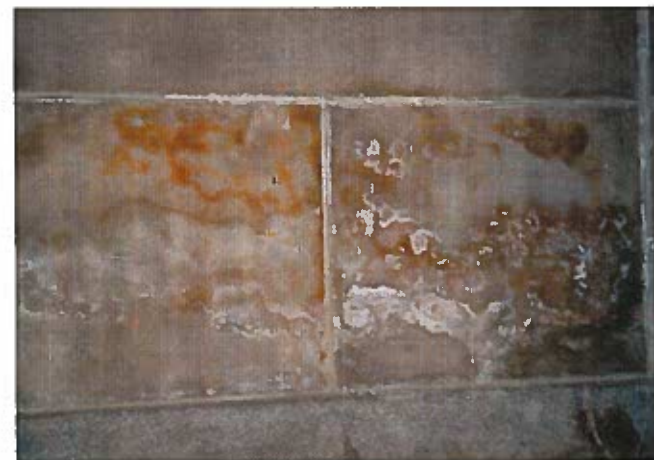
*Efflorescence was observed at several sandstone panels and joints under the stair pavilions and the upper portion of the outer stair support wall.*

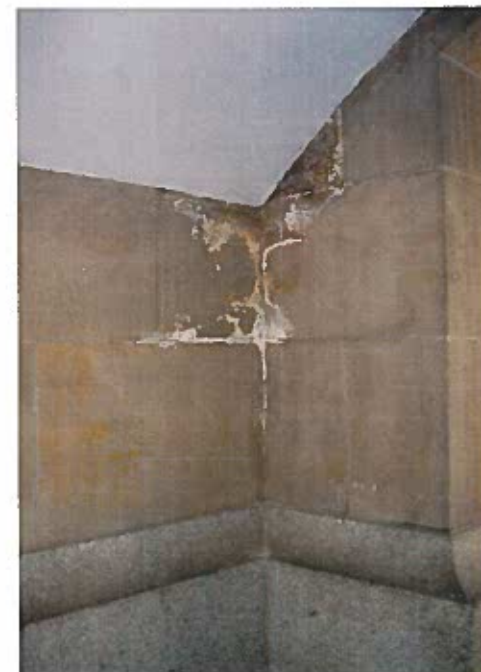
*Isolated sandstone panels located below the granite base course, at the cornice and at the parapet exhibit moderate surface loss from weathering. Weathered stone exhibits a change in surface texture. Rounded corners and deeply grooved surfaces are typical of heavily weathered panels.*

- Remove biological growth, stains and dirt accumulation from sandstone surfaces.
- Remove ferrous stains and efflorescence.
- Redress or replace exfoliated sandstone and granite units.

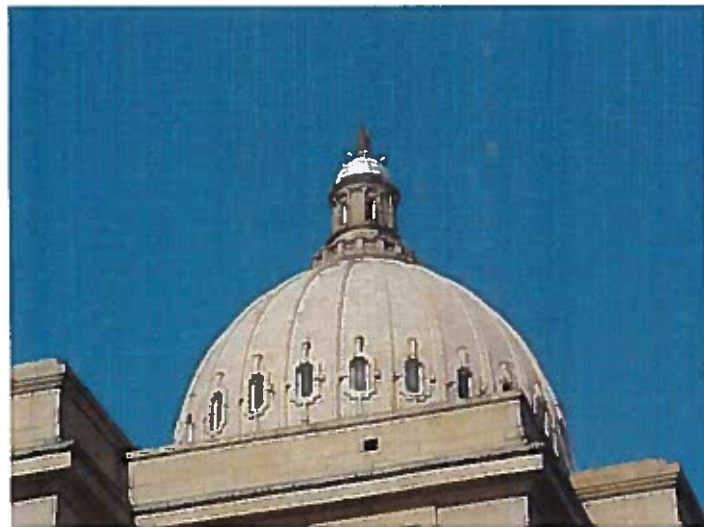
*The main dome is clad in terra cotta adhered by means of a cable system that wraps around the perimeter of the dome above a waterproof membrane of layered asphalt. This allows the terra cotta to be independent of the concrete dome, protecting the interior structure from any moisture that might migrate through the outer skin.*

*The lantern dome is made of a single piece of sandstone waterproofed with a silver-colored coating. The area of roof over the colonnade surrounding the drum is roofed with foil backed modified bituminous roofing. The walkway between the colonnade and drum is paved with quarry tile over copper flashing. The roof access is capped with copper flashing.*

*All roof areas at the dome, drum and lantern are in good condition, except for the sealant at the quarry tile walkway and the flashing over the roof access. The sealant around the perimeter of the quarry tile is loose and deteriorated. The copper flashing over the roof access is loose and torn.*

- Clean and repair the eagle on the top of the lantern.
- Replace the copper flashing over the access-way to the colonnade.
- Reseal the quarry tile joints at the walkway surrounding the drum.
- Consider cleaning, refinishing or replacing the copper roof on the lower secondary domes.
- Consider removing retrofit roofs over the four central light wells – restore window openings to the court. Consider installing skylight in place of current roofs.
- Replace wire glass in skylights surrounding the drum with thermoplastic lenses.
- Repair leak at flagpole.
- Redesign scupper extensions at drum.
- Redesign access ladders.
- Remove visible telecommunication transmission equipment.
- Consider replacement of windows in drum with divided light units to match original design.

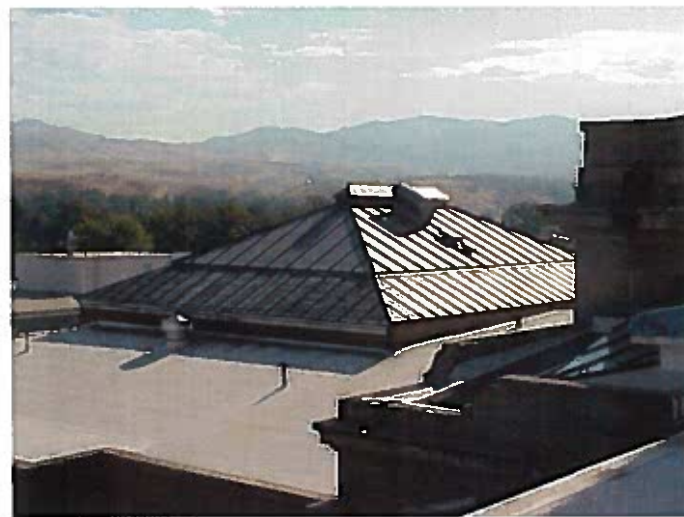
*There are several skylights located on the roof. A large hip-roofed skylight illuminates the present Joint Finance Appropriations Committee Chamber, north of the main dome. The outer edge of the skylight is roofed with standing-seam copper panels.*

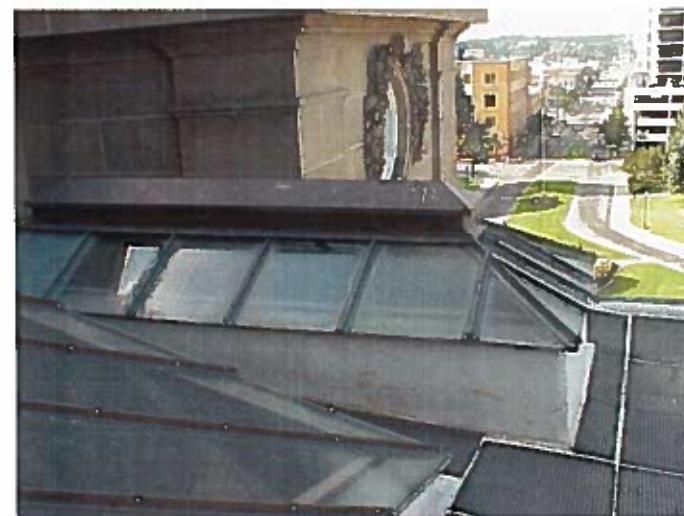
*A band of skylights surrounds the drum. Several smaller skylights are located to the south of the drum. Most of the skylights have been reworked and fitted with thermoplastic lenses.*

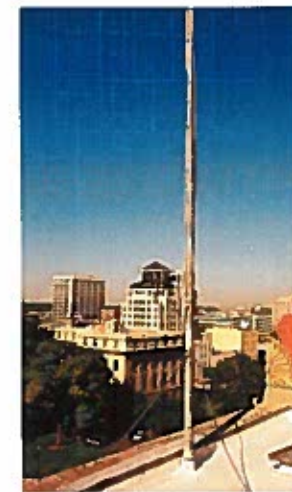
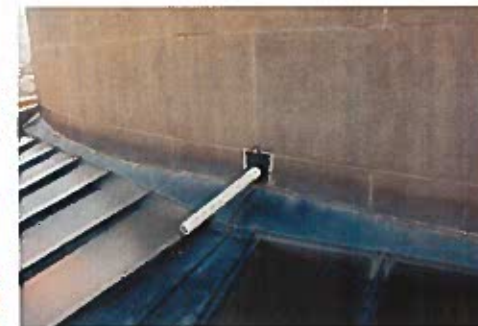
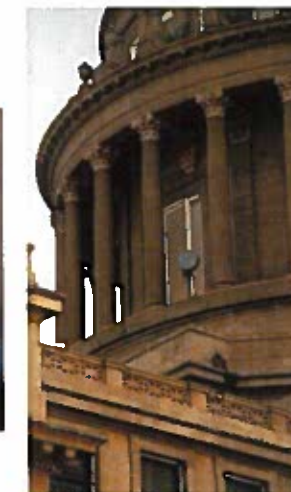
*Some miscellaneous details require attention. One of the flagpoles has a leak in the seam of the pole, allowing rainwater to migrate into the telephone room below (left). Scuppers around the drum have been retrofit with PVC extensions – some of which have come loose (center). Access ladders throughout the roof are substandard. Also, telecommunications transmission equipment is highly visible (right).*

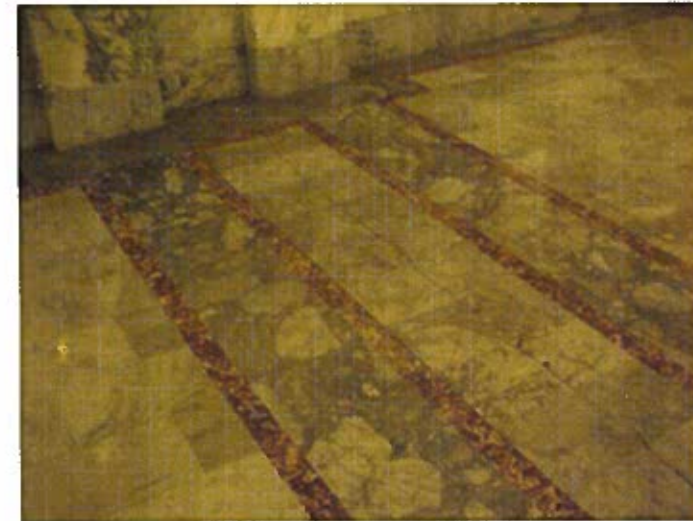
Marble wainscots and pilasters are found throughout the rotunda and public corridors on the first and fourth floors. This marble, from Vermont, has green markings. The walls of the rotunda and public corridors on the second and third floors are entirely clad in marble. Marble wainscots and flooring are also used within the Council, House and Senate chambers and for the stair and rail construction in the rotunda, including marble balusters.

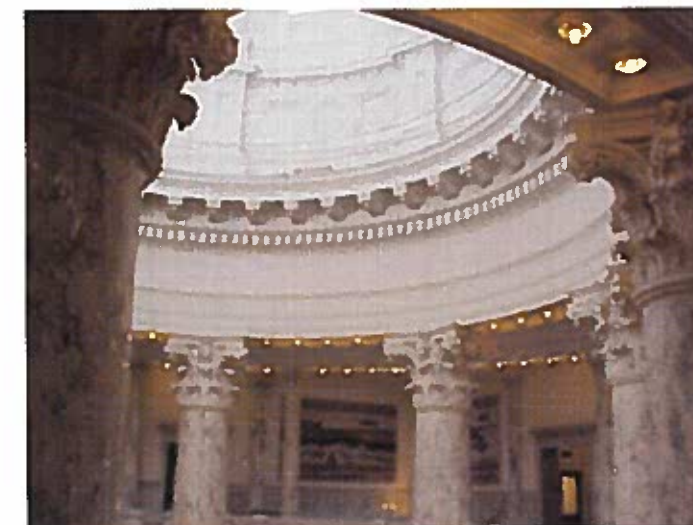
Columns throughout the building are constructed with a simulated marble finish called scagliola. Scagliola is made of plaster comprised of marble and granite dust, sharp sand, alum cement and silk thread.

*Columns currently show signs of aging, displaying hairline cracks in various degrees of severity. The columns in the House (above) and Senate chambers appear to have more cracks than the columns in the rotunda due to higher use and abuse with furnishings.*

- Repair cracked, chipped and/or stained marble panels. Repoint joints.
- Clean/polish marble throughout the building. Level uneven floor panels.
- Restore scagliola columns.

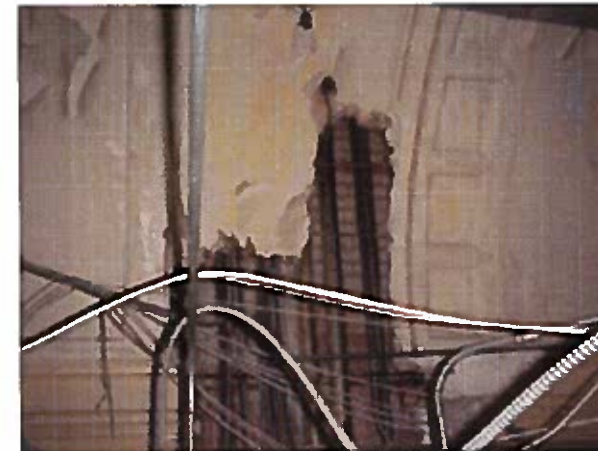
*Most plaster elements above lay-in ceilings have been severely damaged by the installation of mechanical, electrical and ceiling systems. Upper portions of wood window casings have also been damaged by the installation of lay-in ceilings.*

- Repair and repaint decorative plaster finishes.
- Remove lay-in ceilings. Repair damaged decorative plaster detailing and wood window casing above existing lay-in ceilings.

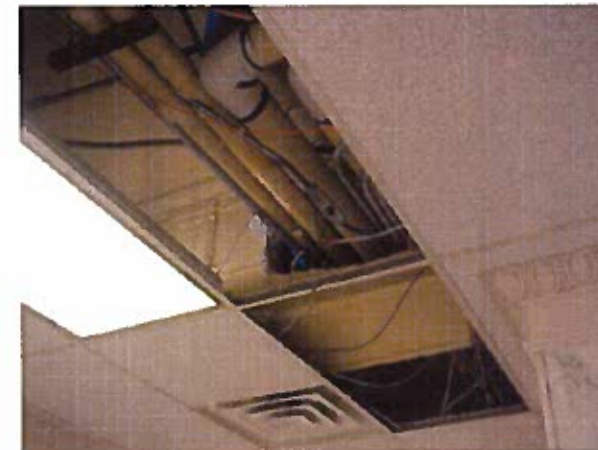
*Consideration should be given to removing lay-in ceilings in areas with original decorative ceiling elements.*

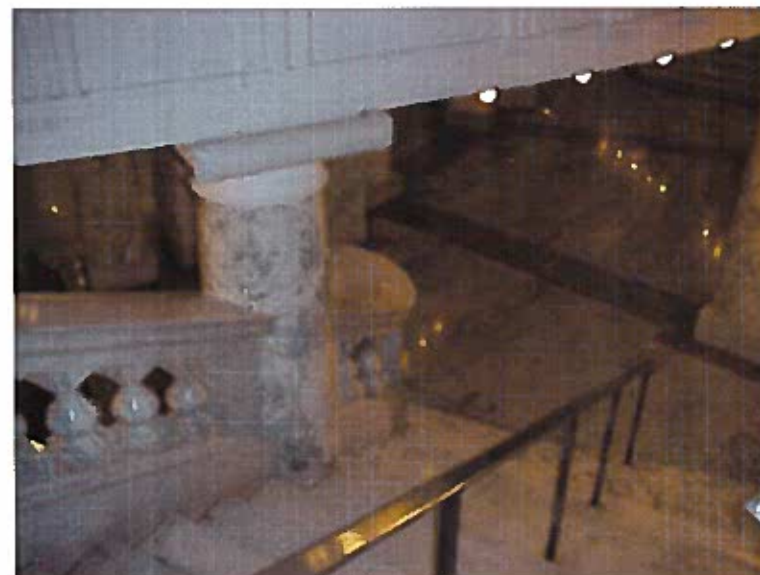
*The plaster caps on the top of columns adjacent to the first floor rotunda stairs are retrofit with cushions to protect occupants from injuring themselves on the low projecting corners. Aluminum handrails have been added without proper consideration of original architectural details or materials.*

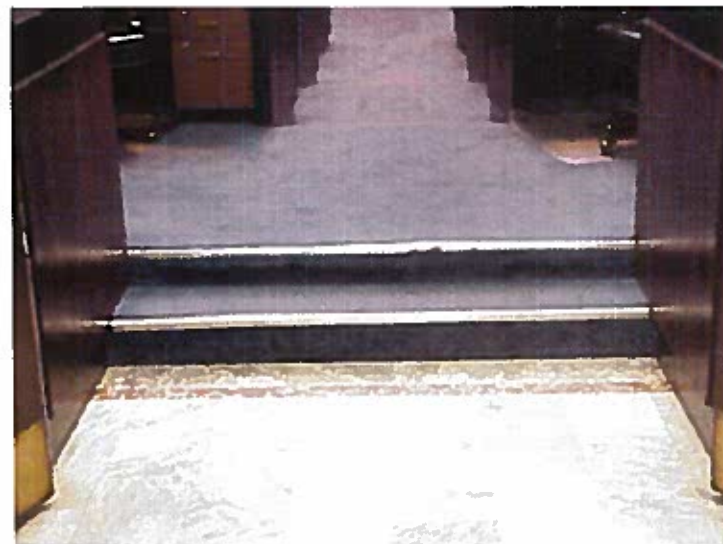
*The original cork floors in the House and Senate chambers have been covered by a stepped floor system and carpet.*

- Restore wood and cork floors.
- Refinish woodwork as needed.
- Refinish scratched and marred interior wood doors throughout.
- Restore and repair door hardware to original condition throughout.

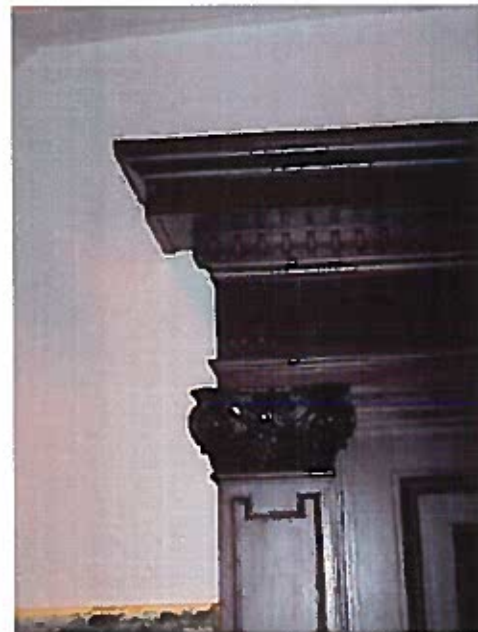
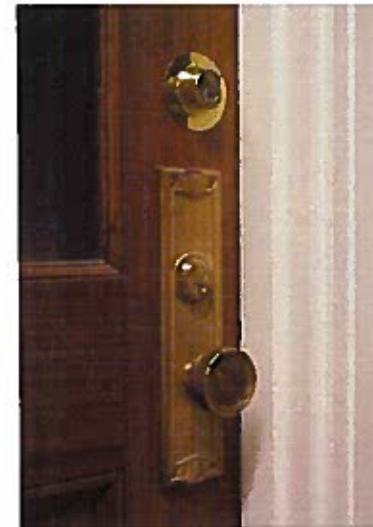
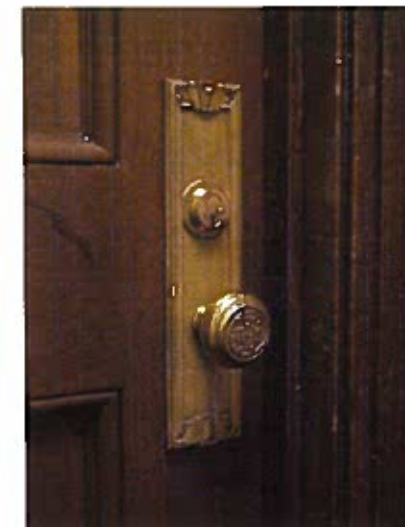
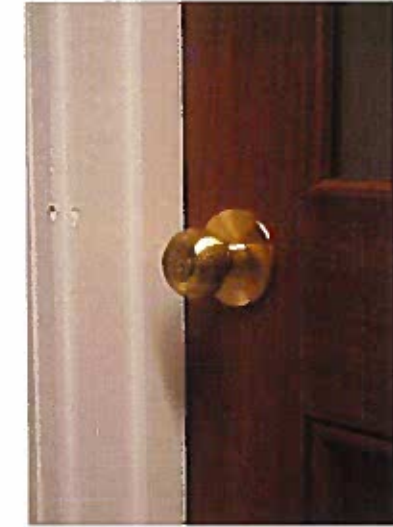
*Some of the hardware and screws are missing at various locations. Some hardware is mismatched.*

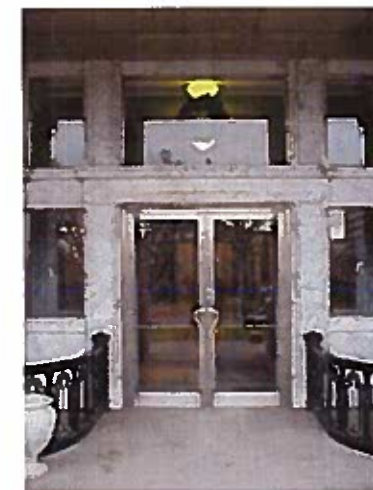
*Exterior doors and frames at main entries are stainless steel with the exception of the north entry doors and frames (left, second floor east entry).*

- Replace stainless steel and anodized aluminum exterior doors and frames with brass to match original.
- Restore original toilet room finishes and fixtures.

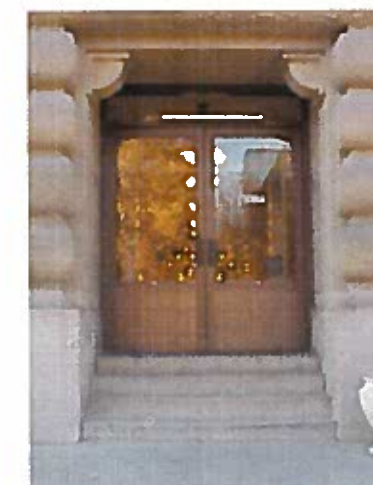
*The north entry doors have been replaced with bronze anodized aluminum.*

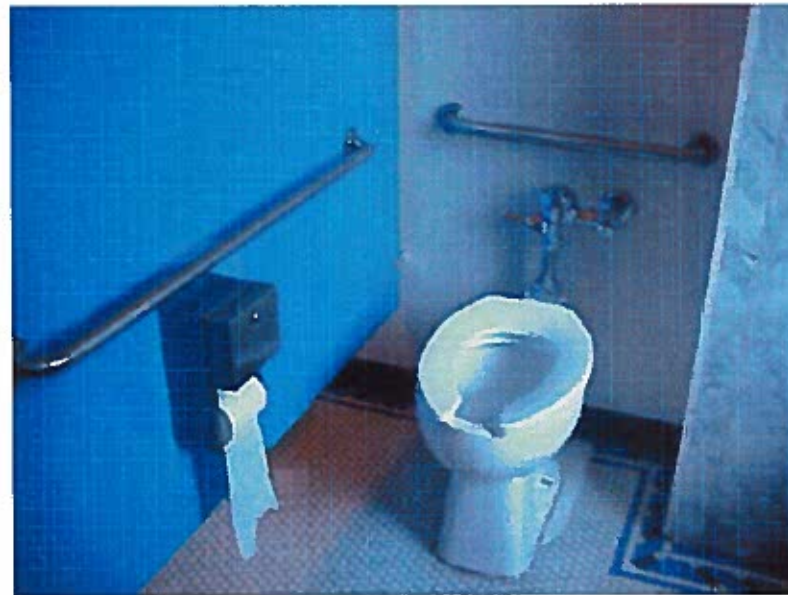
*Finishes in the public toilet rooms are varied. The first and second floor men's rooms have retained the original floor tile. The original marble toilet partitions have been replaced with metal partitions (left, first floor men's toilet room).*

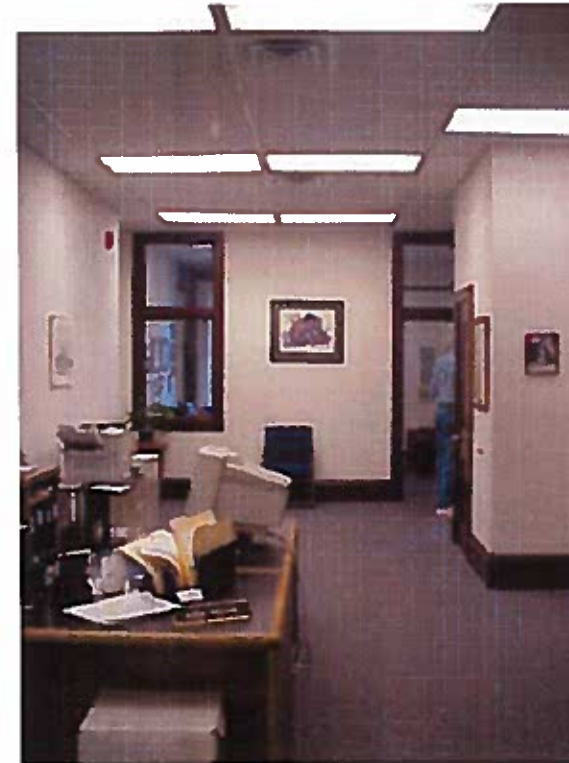
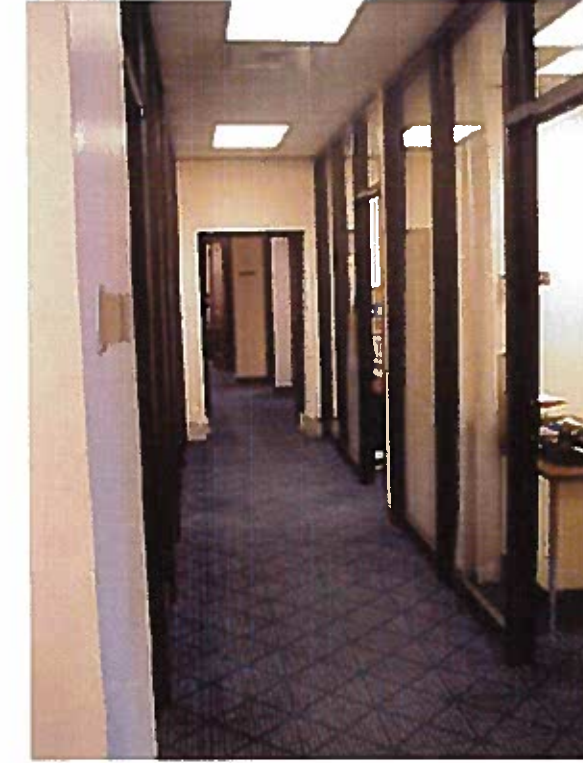
*Finishes in office areas vary. Most finishes, although in good condition, are not original construction (above left, Attorney General's Office; above right, aluminum and glass partitions at Financial Management Office).*

- Remove or replace contemporary finishes that are not in keeping with the original finish palette.
- Preserve existing brick walls on the fifth level above the Statuary Hall.

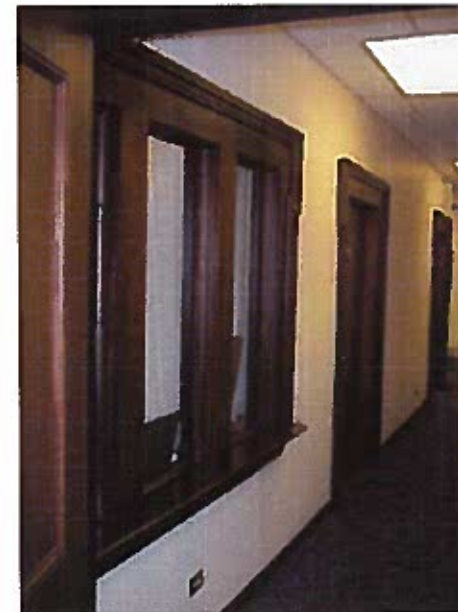
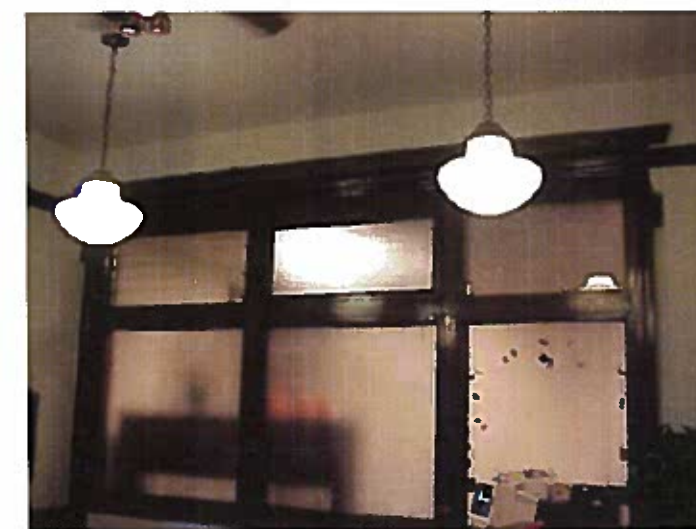
*Some original walls and woodwork remain in office areas, but most details and finishes are contemporary in nature (above left, original door and window frame at Financial Management Office; above right, original banker's partition at Treasurer's Office).*

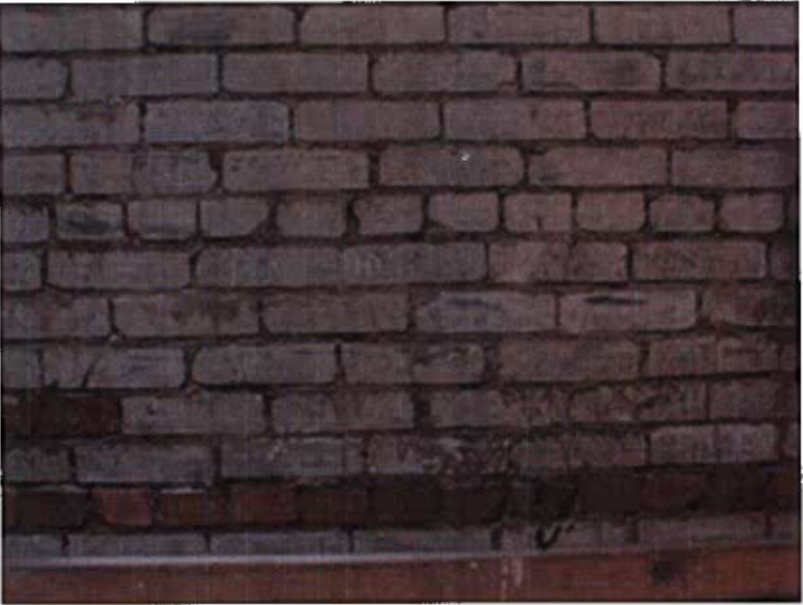
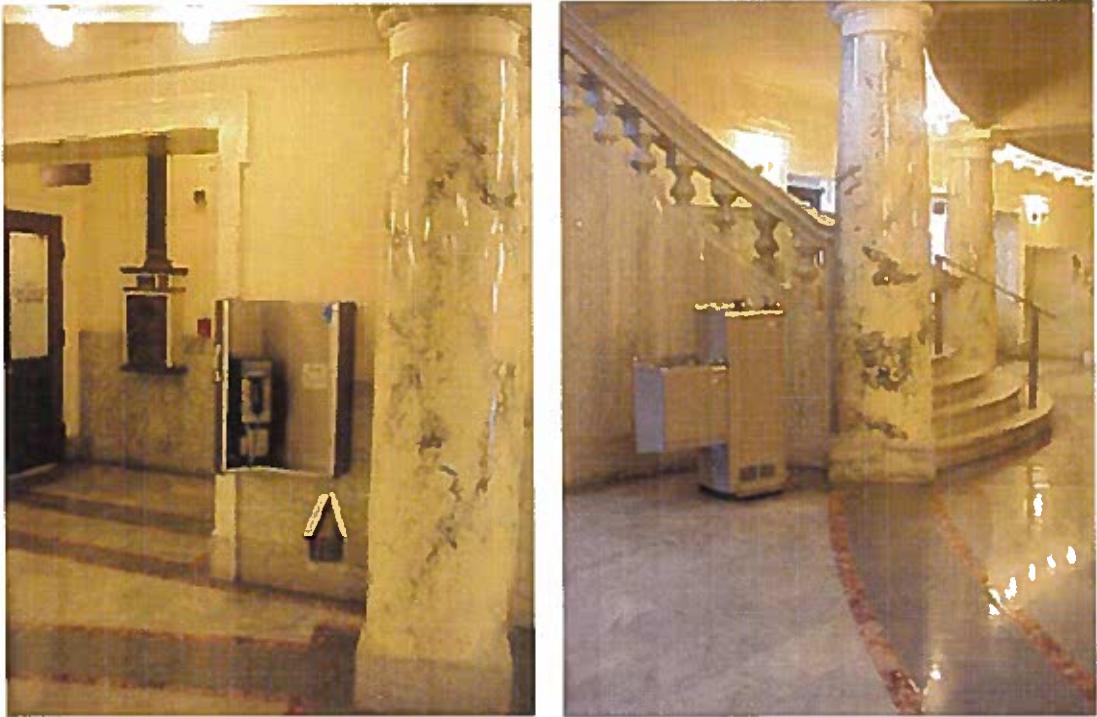
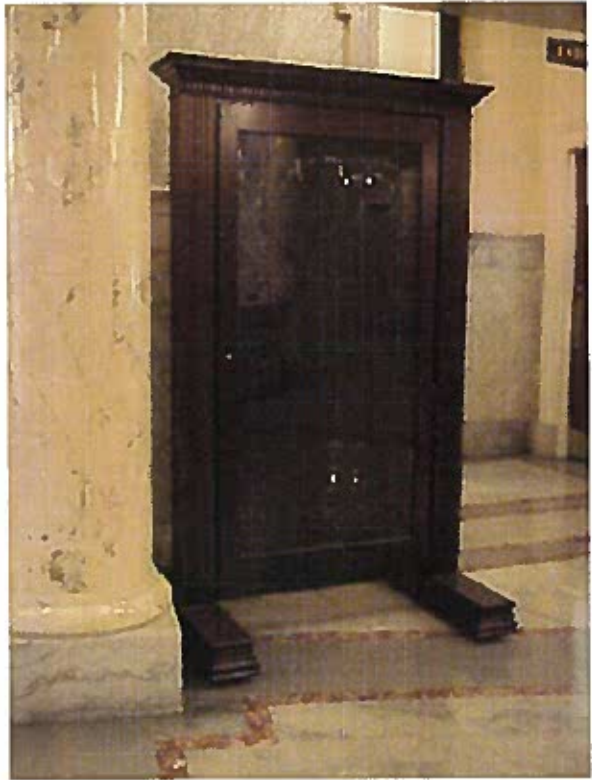
*There are a variety of objects displayed throughout the building, many of which are displayed in cabinets. Little or no consideration has been given to matching one cabinet to another. Cabinet materials range from colored laminates to finely detailed woodwork.*

- Remove, replace or renovate non-historic items, including drinking fountains, public phones, HVAC wall units and display cases mounted in public corridors and entranceways.

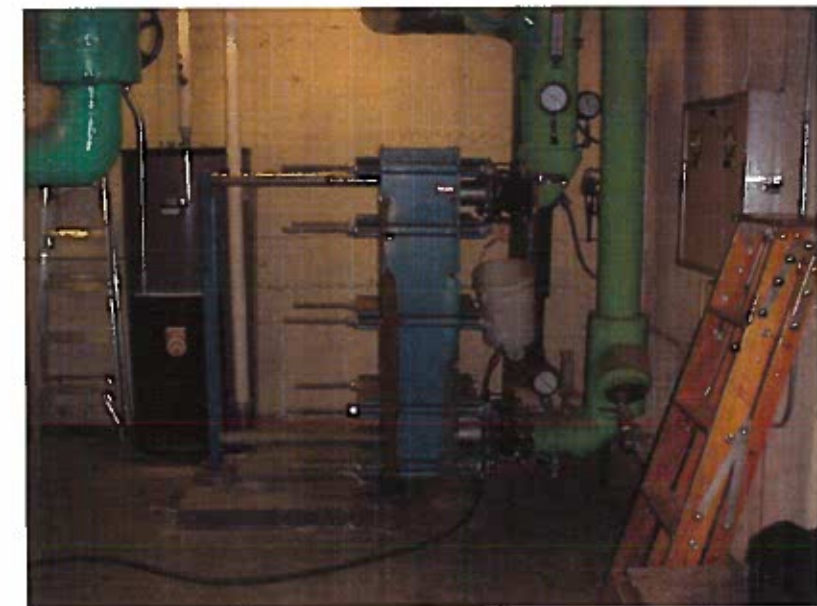
*Geothermal heat service*

The central hot water plant in the basement appears to be in good working order and sufficiently sized to serve the needs of the building. The geothermal water temperature was observed to be 156°F and reported to be very reliable and steady. Access to equipment is adequate and replacement/repair should occur as equipment fails.

Extensive controls, branch demolition to the basement and redistribution will occur as the individual space requirements are changed. In addition, the secondary pumps will have to be replaced as the system head pressure and flow requirements change with the restoration.

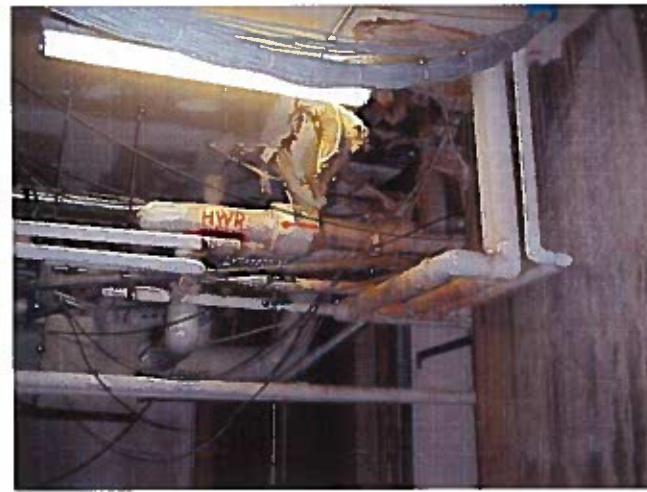
*Hot water piping in shaft*

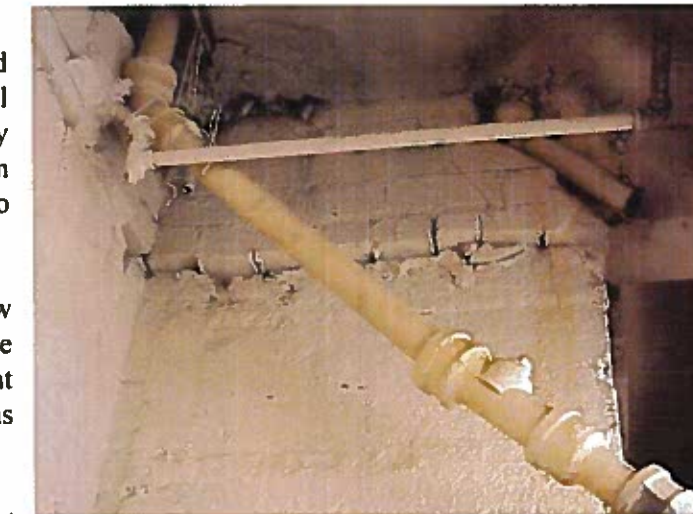
There are five sewage ejector pumps located in various locations serving the Capitol building. They are dated and have had a history of reliability and service access problems. In addition, rainwater leaders were observed to be served by this system.

Much of the service is of original clay. New services are iron pipe, some of which are located in the shafts originally used as light wells. Little accurate documentation was found.

*Cast iron sanitary sewer pipe in basement*

The entire system should be replaced as part of the restoration. There are routing conflicts, material deficiencies and code issues that need to be resolved in order for this system to fit into the restoration plan. Extensive demolition to the existing piping systems and the addition of lift stations dedicated to sewage systems where the collection is below site utility connections.

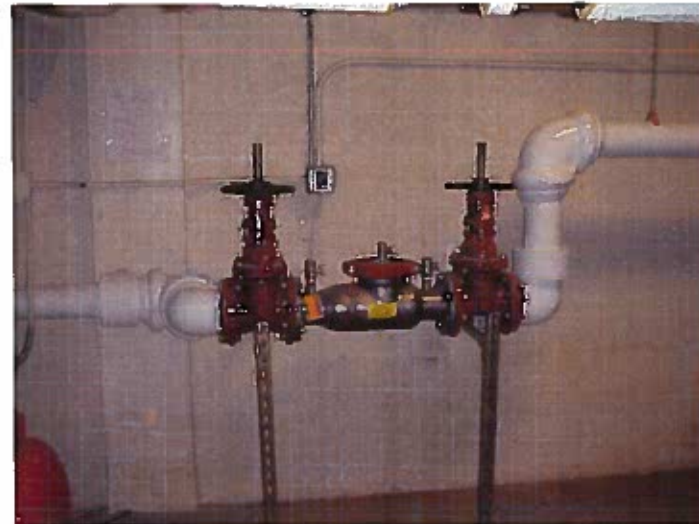
*Backflow preventor*

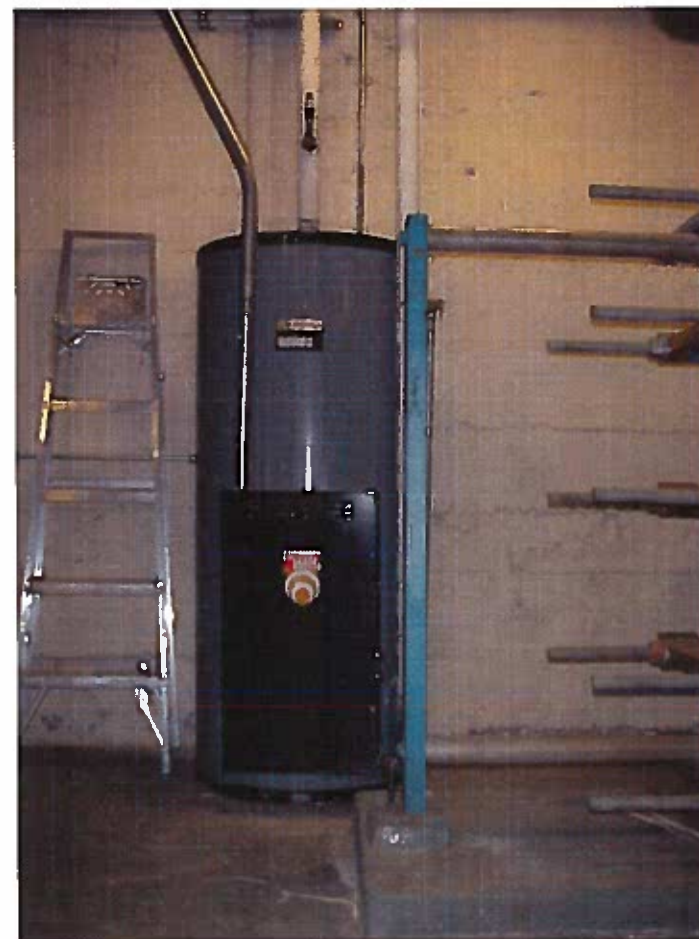
There is an electric hot water heater located in the basement that serves as a central hot water heater. In addition, many small remote electric water heaters have been installed throughout the building as tenant spaces change. The system provides adequate hot water, except at some intervals when the legislature is in session. There are maintenance issues with the small remote water heaters as a result of their high failure rate.

*Domestic hot water service*

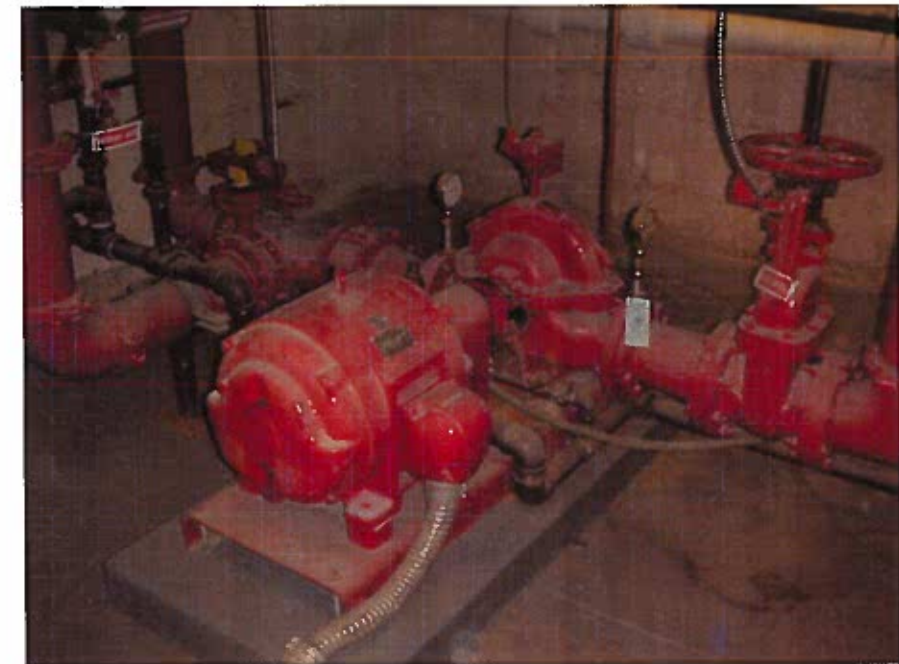
system with sprinkler coverage of a light hazard occupancy classification. There is a 750 gpm electric motor driven pump with a pressure maintenance pump located in the basement serving the fire sprinkler system. There are currently two standpipes. One stand pipe is a 3-inch line and the other a 6-inch line with fire pumps and connections to the water main that are capable of serving the building with the exception of the south wing.

*Fire pump*

Fire sprinkler service is recommended for the remainder of the facility. Since the existing risers are located in shafts that are intended to be used as light wells, they will be demolished and new riser locations will be provided to route new riser piping capable of serving the entire building. Individual water alarm devices, supervisory subsystem isolation valves and system drainage shall be provided so that each floor and wing will be alarmed, supervised and drained.

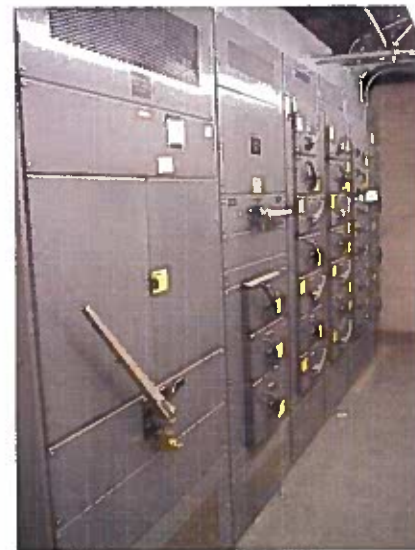
The existing electrical service is a 208Y/120-volt, 3-phase, 4000-amp, fused switchboard. It is fed from the medium voltage, west branch of the Capitol Mall distribution system through a transformer bank just outside the building with 4000-amp bus-duct; and was placed into service in 1967. While the equipment is over 30 years old, it appears to be in good shape and would not necessarily require replacement due to its physical condition alone. The construction of the gear (the fused switch type) makes it physically large and there is insufficient space for the addition of new branch devices. This not only prohibits future expandability; but also makes it difficult to phase the construction process in a manner that will allow the building to remain operational.

Additional electrical loads from new mechanical units, light fixtures and/or other equipment are also a factor to be considered. Therefore, it is not unreasonable to expect that it may be necessary to replace this switchboard as part of the building restoration. If needed, a new switchboard using circuit breaker construction will be installed. This would decrease the physical size required and tends to be just as cost effective as fused switch construction. The incoming 4000-amp bus-duct would also require replacement, as would distribution feeders to branch panelboards throughout the Capitol building.

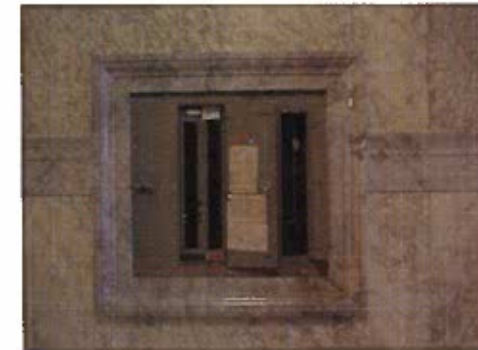
Some of the existing panelboards are located in conspicuous areas such as the hallways from the rotunda area to the east and west exits on the first and second floors. There are also panels located in the House and Senate chambers on the third floor. These panels would be removed as part of the restoration of these areas and will require new panels located in less noticeable spaces. All branch circuits fed from demolished panels would be replaced. Additionally, much of the branch wiring is original and should be replaced in order to guarantee reliability and safety over the next 50 years. Conduit routing will be concealed in walls, above ceilings or beneath "false floors" as architectural work permits.

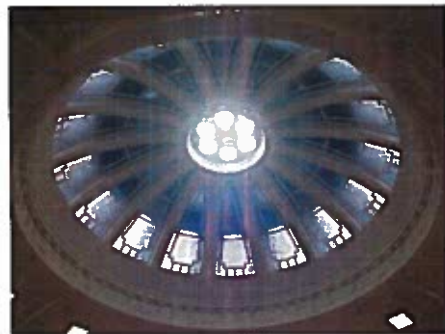
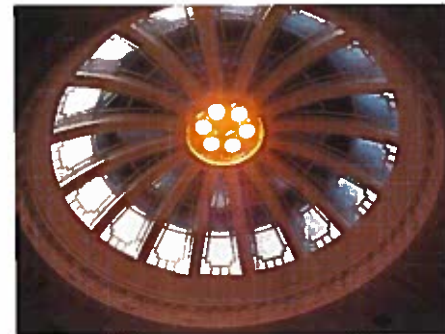
The lights above the House and Senate chambers are high intensity discharge (HID) type lamps. The fixtures in the House dome use high-pressure sodium while the Senate has metal halide. The colors of these lamps are noticeably different from one another with the sodium lamps

being more yellow. Another difficulty with HID lamps is the amount of time necessary for the arc tube in the lamp to reach full intensity after being energized by a switch (commonly referred to as strike time). It is recommended that the fixtures in both chambers be replaced with newer technology, pulse-start, metal halide lamps for color consistency, efficiency and faster strike times.

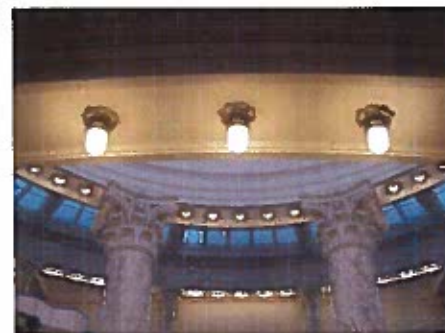
The light sockets in the rotunda appear to be the original design intent for this area. Self-ballasted, compact fluorescent lamps are being used in place of incandescent lamps here and in many of the wall sconces in the building. This may in fact be the best option for lighting in these areas since fluorescent lamps are more energy efficient than incandescent lamps and can burn for 10,000 hours or longer. The lamps in the top two rows are extremely difficult to replace, so the lamps used there should have as long of a life as is available at this time. Although the fluorescent lamps don't look quite the same as the incandescent lamps, this is one trade-off when

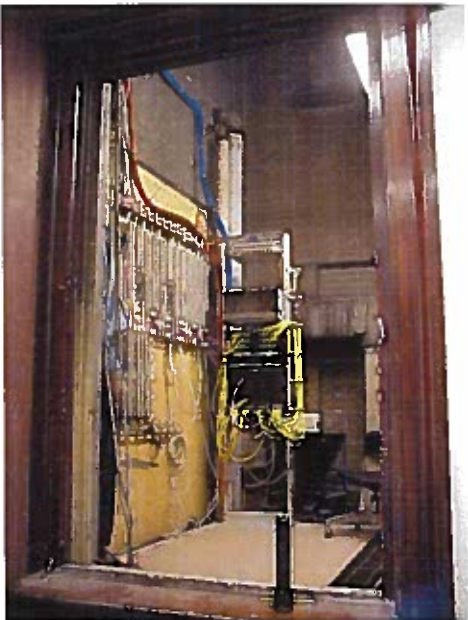
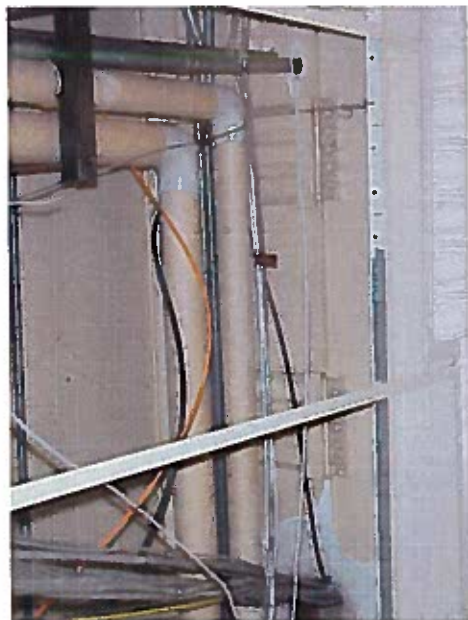
Data and telecommunications systems equipment, cabling, wiring and panels have been installed in former light shafts, elevator shafts or other "found" spaces throughout the building.

Initial installation and relocation of data and telecommunications systems cabling has been randomly placed and, when abandoned, left in place.

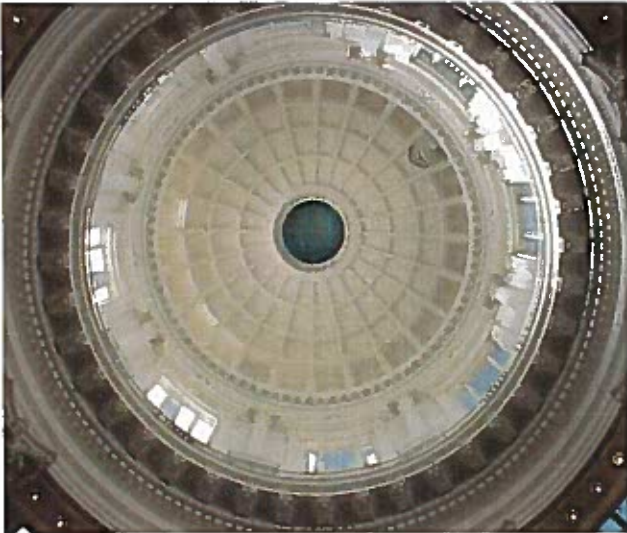
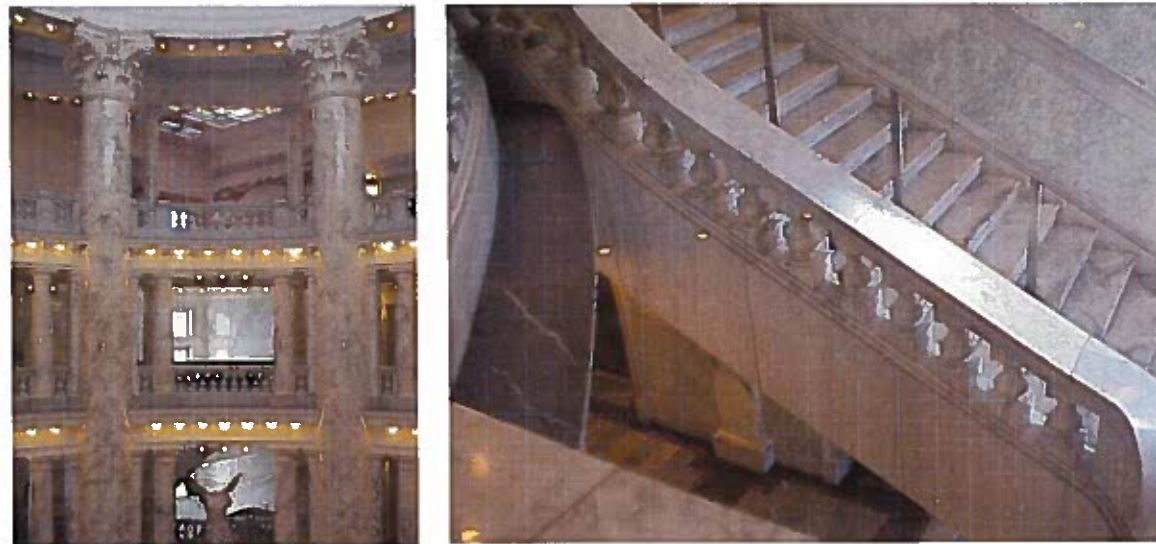
The UBC requires all areas open to the atrium to have a smoke-control system that actuates automatically with the fire sprinkler system. Standby power is required to operate the smoke-control system in the event of a power outage. The rotunda is not equipped with either of these systems.

By code, the rotunda is required to be separated from the balance of the building with one-hour fire-resistive construction. Stairways within an atrium space are to be enclosed. The rotunda is open to the first and second level corridors; the adjacent spaces on the third and fourth levels are separated with non-rated assemblies; and the stairways are unenclosed.

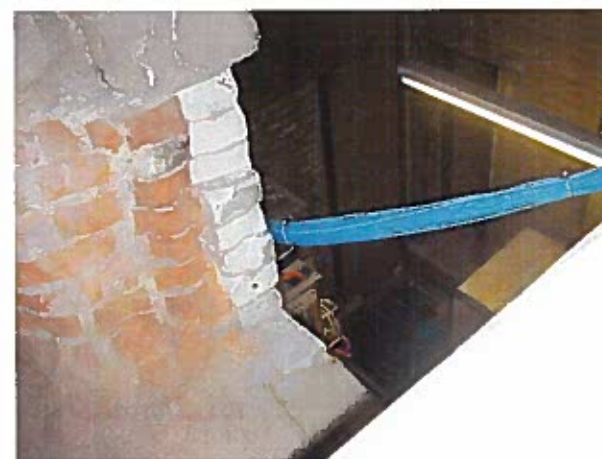
Elevator shafts should also be enclosed with fire-resistive wall assemblies. The elevator shaft on the east side of the rotunda is open to the attic space above the fourth floor. Shafts housing elevators extending through more than two floor levels should be vented to the outside with a minimum vent area of 3 square feet per elevator. The elevator shaft on the east side of the rotunda is not vented to the outside.

*Opening to shaft in attic*
