# IDAHO STATE CAPITOL MASTER PLAN

For the Preservation, Restoration and Rehabilitation  
of Idaho's Statehouse

July 19, 2000

DPW Project #99.014

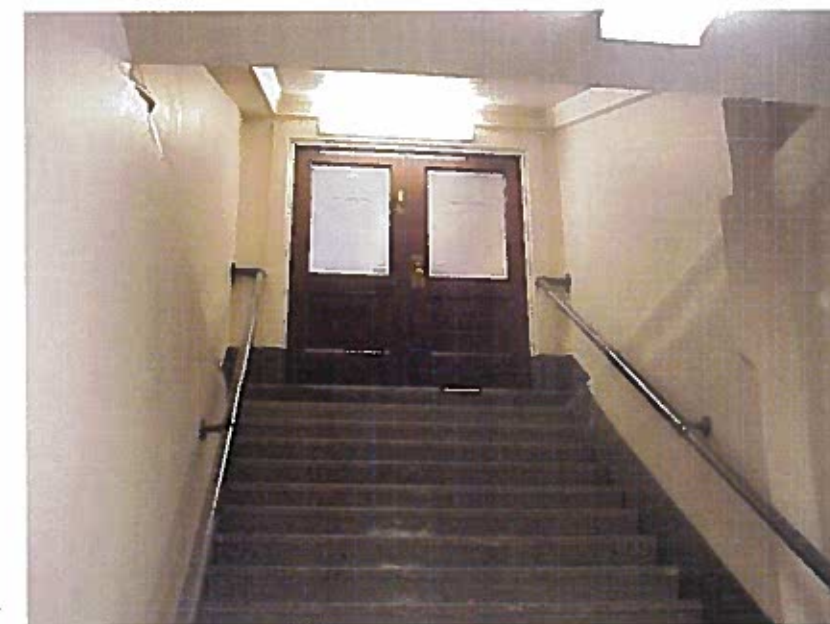
*Basement stairs*

Stairs greater than 88 inches in width shall be provided with not less than one intermediate handrail. The top of each handrail shall be between 34 and 38 inches above the nosing of the treads. Handrail cross-sectional dimensions shall be between 1 and 1/4 and 2 inches. The basement stair has handrails greater than 2 inches in diameter. The north and south exit stairs have no handrails.

- Correct deficiencies in handrails and stair landings at required exits.
- Consider augmenting and/or raising guardrails at locations determined to pose a hazard.

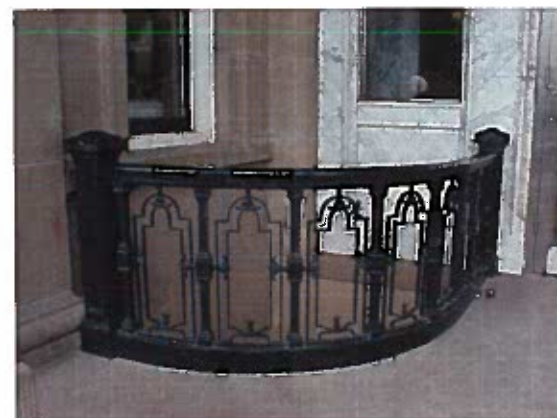
Second floor light well

The guardrails surrounding the small light wells at the east and west second floor entries are only 30 inches high. The railing pattern has openings greater than 4 inches in dimension.

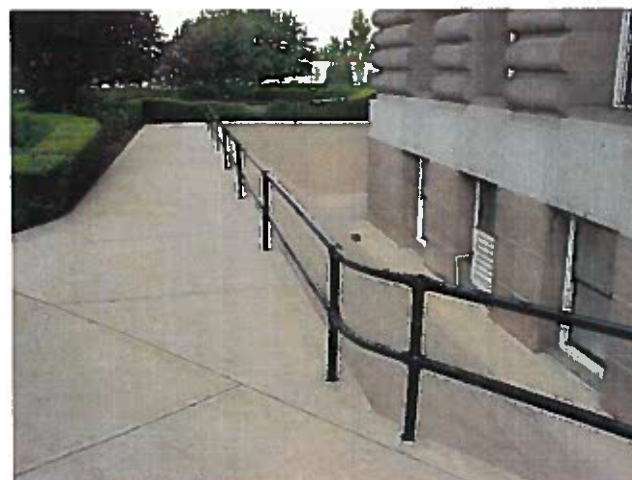
*The guardrails surrounding the exterior basement areaways are only 29 inches high and have only one intermediate horizontal rail. Some original drawings indicate protection for these areaways were intended to be a single chain spanning between posts. The sides of the well are sloped; however, there is still a potential for injury should someone fall over or through the railing.*

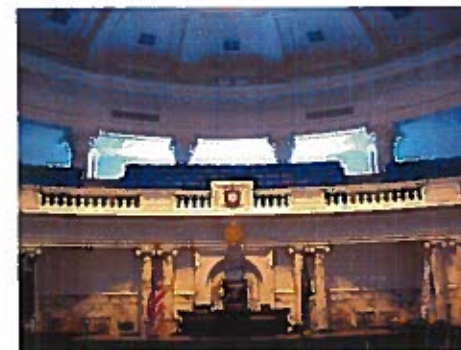
*The House and Senate gallery guardrails are only 24 inches in height along the length of the balcony at all locations. By code, guardrails on a balcony immediately in front of the first row and not at the end of an aisle shall be a minimum of 26 inches high. Guardrails at aisles and other locations shall be augmented to a minimum height of 36 inches. Railings surrounding the rotunda balconies are 36 inches high.*

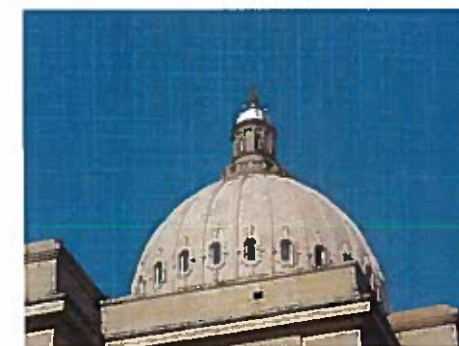
Lantern access ladder

The main dome is accessed by a route through the fourth level attic to an exterior stair inside the colonnade surrounding the drum. The exterior stair provides access to the interior spiral staircase on the interior upper level of the drum, which leads to the attic space inside the dome. Another spiral stair leads to the balcony surrounding the lantern. From this location, a steel cable ladder provides access to the lantern dome. Access to areas of the attic and dome can be hazardous.

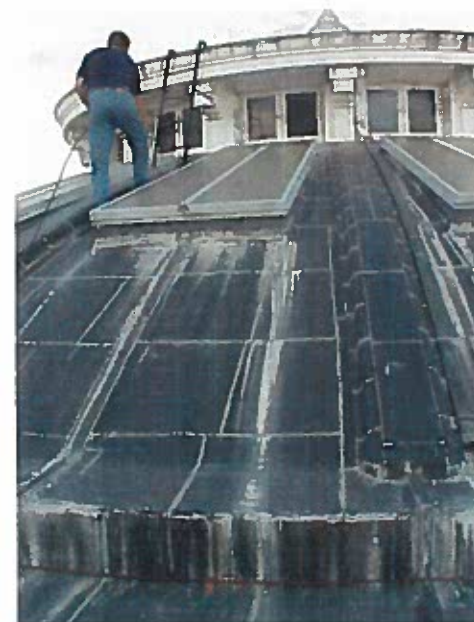
Senate dome access

Access to the House and Senate flagpoles is gained from the main roof by use of a steel cable to traverse the lower dome and short steel ladder to access the upper dome. While the roof is not excessively steep, a hazard exists under wet or icy conditions. The flagpoles at the edge of the roof over the south entry do not have a guardrail.

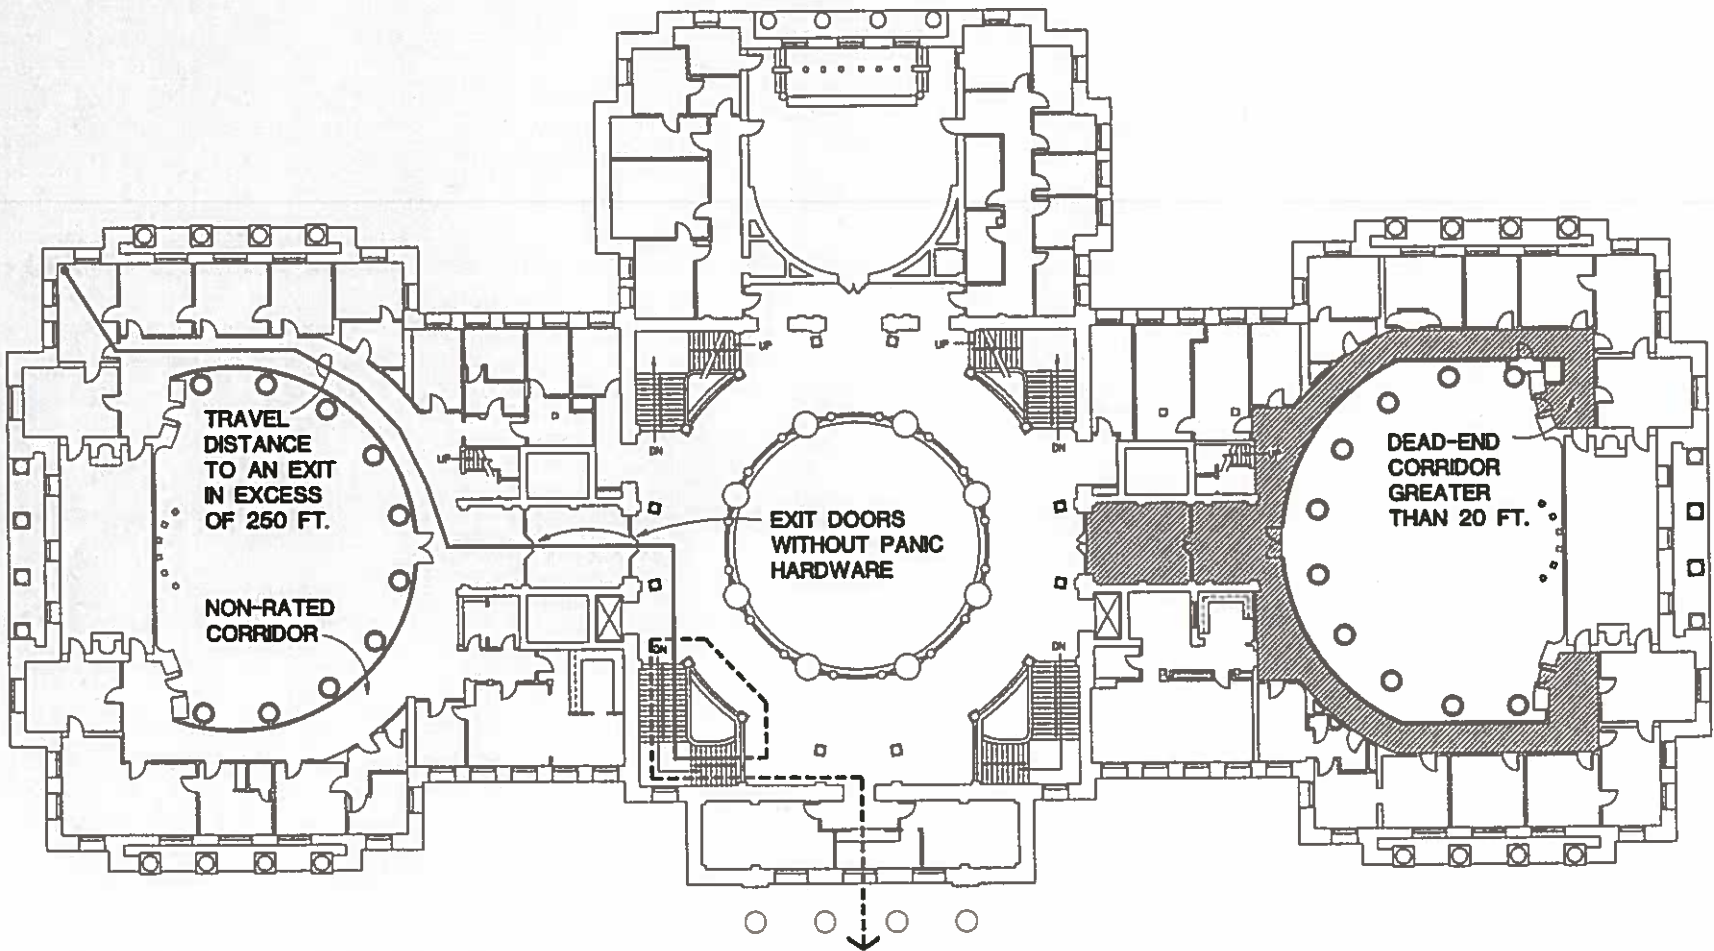
THIRD FLOOR PLAN

The third and fourth floors have only one exit, unenclosed, through the rotunda. By code, these floors require a minimum of two exits, separated by a minimum of one-half the maximum diagonal dimension of the floor. The travel distance from the most remote locations on these floors is in excess of 250 feet. The corridors serving the east and west wings have dead-ends in excess of 20 feet.

In addition, the exit access doors serving the east and west wing assembly chambers and galleries have locks and latches without panic hardware.

- Consider methods for reducing dead-end corridors.
- Provide accessible toilet rooms and drinking fountains.
- Address issues of hazardous protruding objects.

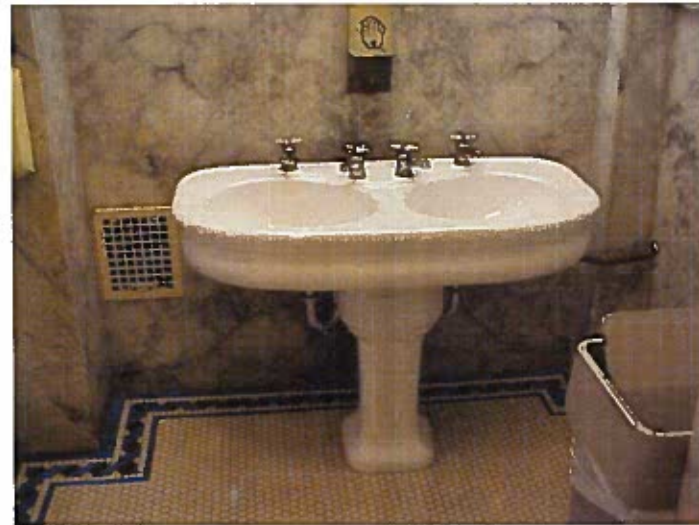
*First floor men's room*

Existing toilet rooms are not completely accessible. At least one of each type of fixture or element in each toilet room shall be accessible; however, if removing architectural barriers or providing accessibility would threaten or destroy the

historic significance of a building or facility, an accessible unisex toilet facility may be provided along an accessible route.

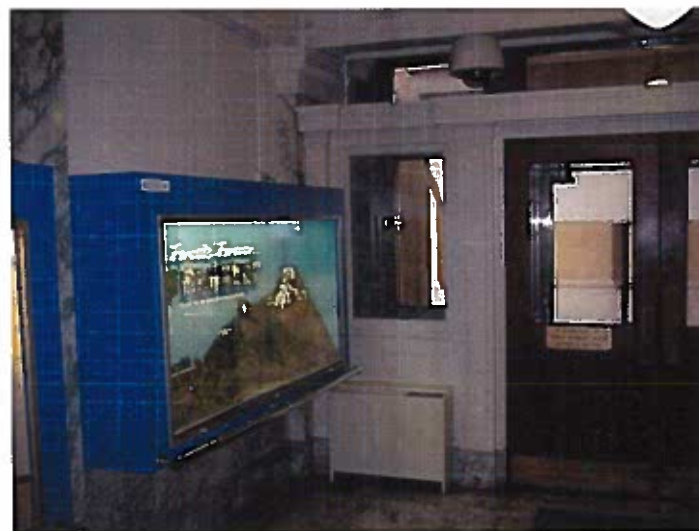
*Display case*

The display cases on level one protrude into the corridor, presenting a hazard for the visually impaired. Objects projecting from walls with their leading edges between 27 inches and 80 inches above the finish floor shall protrude no more than 4 inches into corridors.

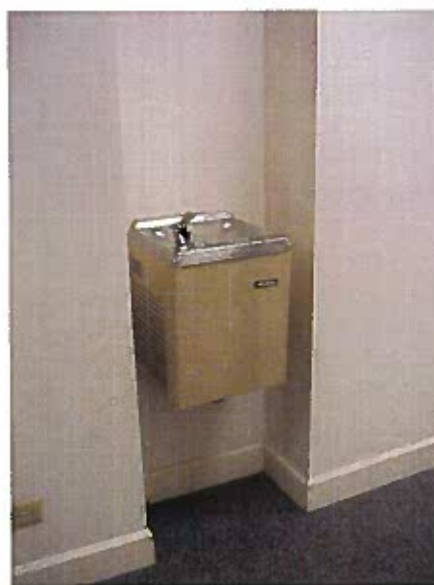
*Basement drinking fountain*

The basement and level one do not have accessible drinking fountains. On any floor where drinking fountains are provided, at least 50 percent, but not less than one fountain, shall be accessible.
